Learn from the mistakes of others; you'll not live long enough to make them all yourself . . . **Issue 1/2004**

Sometimes You Do, Sometimes You Don't...

On June 11, 2002, a Piper PA-31-350 Chieftain was on an instrument flight rules (IFR) flight from Gunisao Lake, Man., to Winnipeg. One pilot and six passengers were on board. At 09:13 central daylight time (CDT), the aircraft began an instrument landing system (ILS) approach to Runway 13 at Winnipeg International Airport. The captain flew the approach at a higher-than-normal approach air-speed, well above the glide path. When the aircraft broke out of the cloud layer, it was not in position to land safely on the remaining runway. The captain executed a missed approach at 09:16, and shortly thereafter, at 09:18, the captain declared a 'Mayday' for an engine failure. Less than 20 seconds later the captain transmitted that the aircraft had experienced a double engine failure. The aircraft crashed at a major traffic intersection at 09:20, striking traffic signals and several vehicles. All seven of the aircraft passengers and several of the vehicle occupants were seriously injured; one passenger subsequently died of his injuries. The

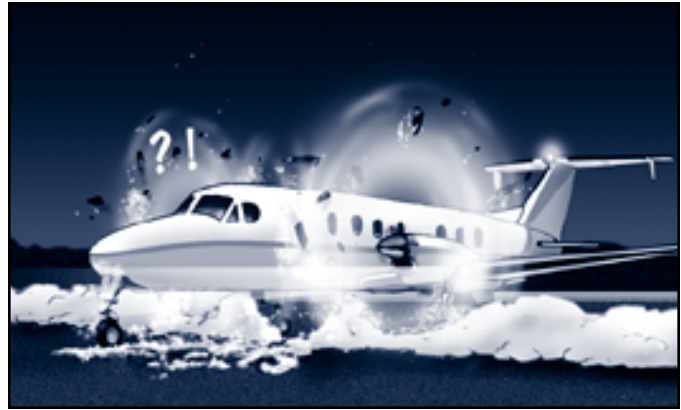
Artist's impression of collision with windrow.

approximately 2 seconds later and 60 ft short of the windrow. When the wheel brakes were applied, the aircraft started to skid on the slippery runway surface. The captain attempted to apply reverse thrust, but there was insufficient time for it to be selected before the nose wheel struck the windrow, at 23.5 kt. The propellers struck the windrow next, followed 1/4 second later by the main gear, which struck the windrow at approximately 20 kt.

The lowest point of the propeller tip path on the Beech 1900D is 14.07 in. from the ground. When the propeller blades struck the 2-ft high windrow, all four blades from the right engine and one blade from the left engine broke off near the hub. The blades from the right engine struck the starboard aircraft fuselage at the forward passenger cabin window. This window shattered and the window fragments and frame were thrown forcibly into the cabin. A mother and her infant, who were seated immediately next to the window, narrowly escaped injury. The crew stopped the aircraft 175 ft past the windrow, secured the engines, shut off the electrical power, and escorted the passengers from the aircraft. The ground controller noticed the passengers deplaning and activated the crash alarm.

Runway 02, from Taxiway Charlie to Runway 29, had not been traversed by any vehicles prior to the accident. The runway had not been cleared during the previous night, and there were no RSC reports produced for the runway. As the location of the windrow north of Taxiway Charlie was well to the north of Runway 16/34, the windrow did not appear on any of the RSC reports produced that night. After the accident, Runway 02/20 north of the windrow was found to be covered with a combination of ice and patches of thin snow.

The crew's previous safe transit through the intersection and the lack of any warning of obstructions along their taxi route resulted in them proceeding with their normal taxi routine, and without extra vigilance for taxi hazards such as windrows. The flat-light conditions and the white background of the uncleared portions of the airfield also caused the windrow to blend into the background, making it less conspicuous from a distance. Approaching the intersection, the crew's attention was diverted by the presence of snow removal vehicles on Runway 16/34 that were approaching their location. During the subsequent taxi check, the first officer was reading the checklist and the captain's attention was focused inside the cockpit, as he was verifying his flight instruments. These actions and the inconspicuousness of the windrow prevented the crew from seeing it earlier.

The taxi speed of the aircraft and the icy condition of the runway hindered the stopping of the aircraft, and consequently did not allow time for the captain to apply reverse thrust. Had the aircraft's taxi speed been less, more time would have been available for the crew to recognize and react to the windrow. With more time to react, it is possible that the crew could have stopped the aircraft prior to the collision.

As a result of this occurrence, the St. John's Airport Authority has issued a memorandum, which allows the lead hand to close Runway 02/20 when conditions require. △
