Transport  
Canada

Issue 4/2010

# Feedback

Canadian Aviation Service Difficulty Reports

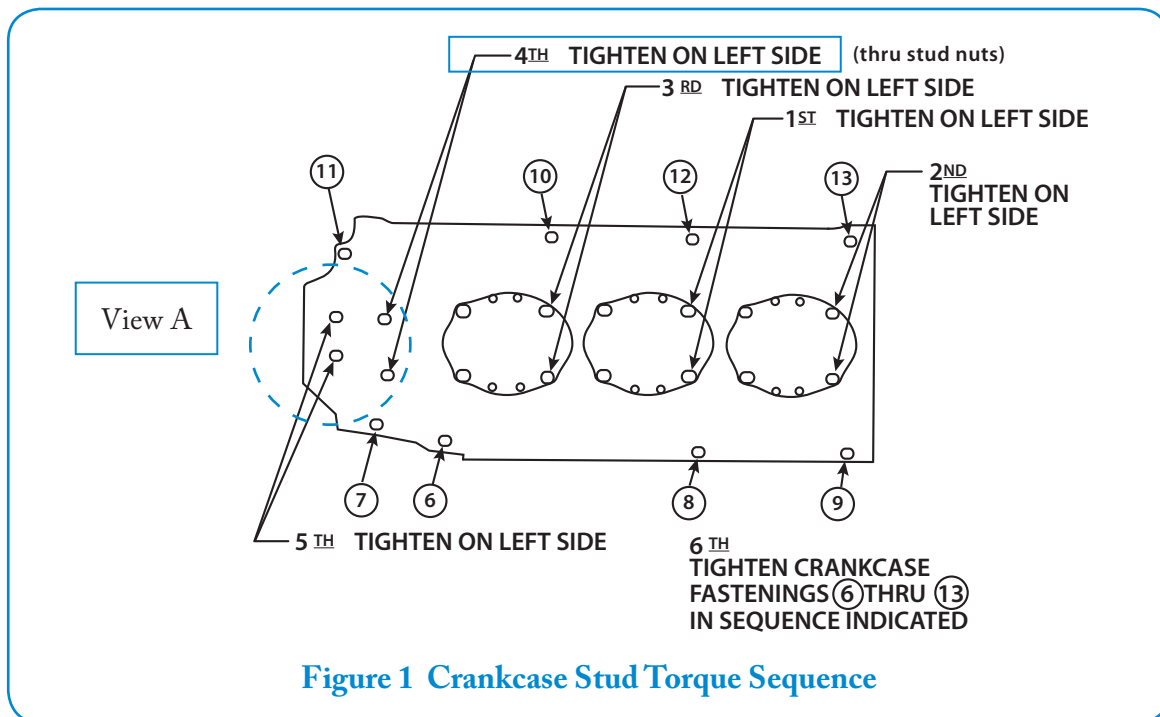
Figure 1 Crankcase Stud Torque Sequence

The Teledyne Continental Motors Maintenance and Overhaul Manual specify the correct procedures and sequence for the application of torque for the engine case stud nuts as seen in figure 1. Information gathered during the investigation found that it is a common practice to apply torque to the nuts only on the side of the engine for the replacement cylinder, and that these nuts are

not changed unless obviously worn. The nuts on the opposite side (as seen in figure 3 as thru studs) must also be tightened to the proper torque in conjunction with the application of lubricating oil. The manufacturer has provided information that the non-use of lubricating oil or the failure to apply the proper torque will result in an under tension condition on the thru studs and eventual failure of the engine.

Therefore, Transport Canada Civil Aviation emphasizes to all aircraft owners and operators the importance of following the manufacturers’ instructions. In particular even if only one cylinder is being replaced all engine case nuts and thru stud nuts need to be properly retorqued. ✖

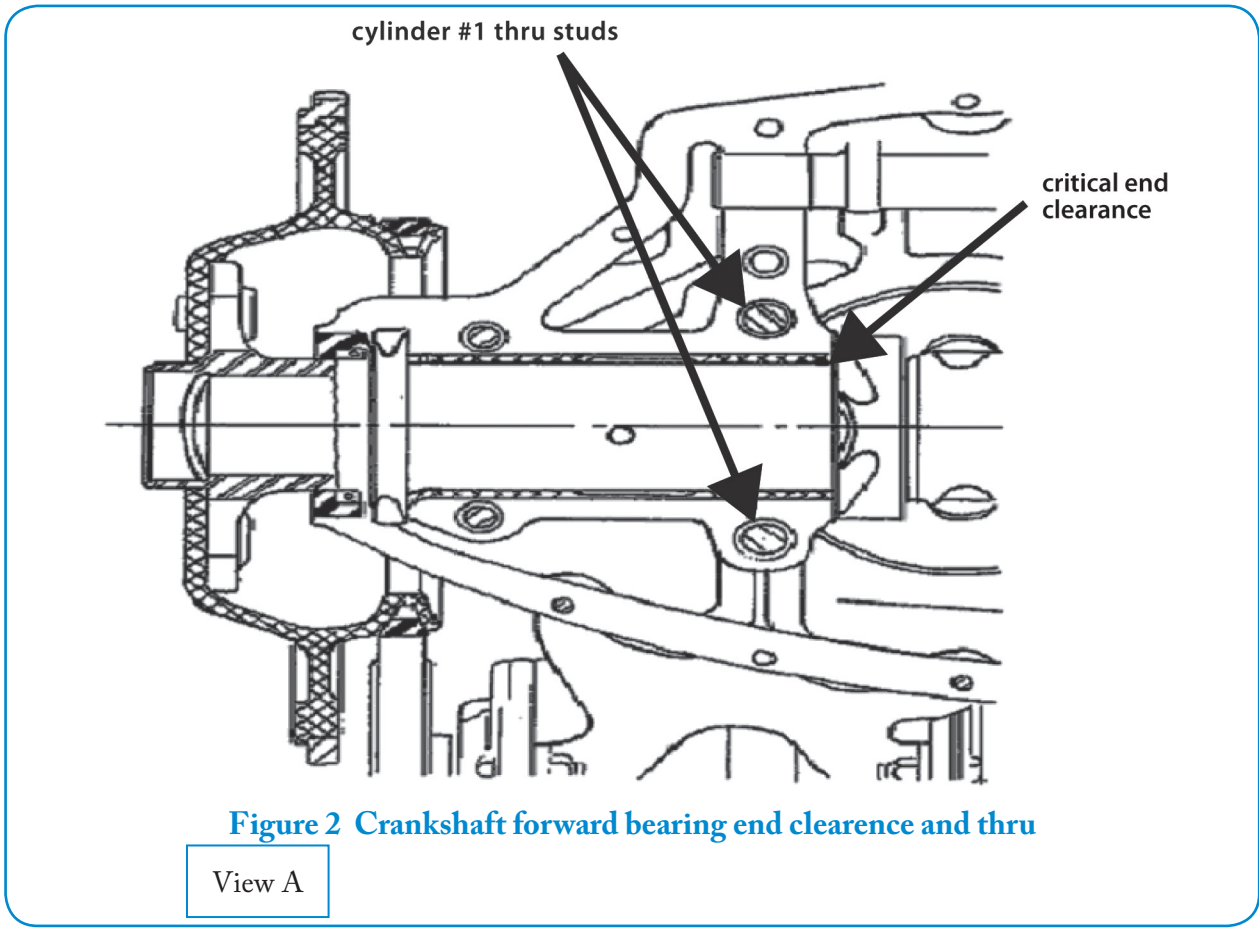
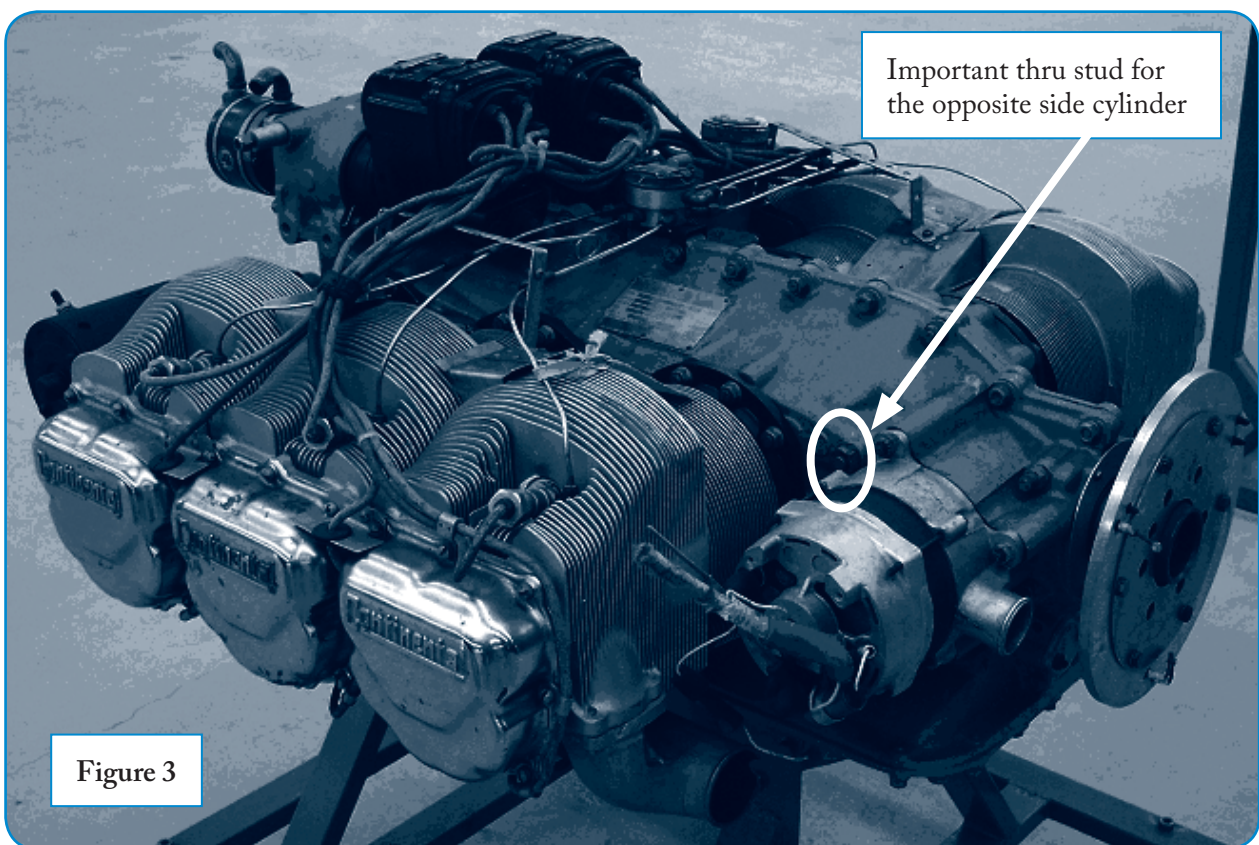
Engine case halves that are loose will allow bearings to work themselves out of place as a result of various action/reaction forces during normal engine operation. This bearing may then move, closing the essential end clearance as seen in figure 2 (view A), and make contact with parts of the crankshaft, resulting in the creation of stress risers and eventual failure of the crankshaft.

Loose engine case halves will not retain bearings in the proper position as a result of various action/reaction forces during normal engine operation. If the essential end clearance as seen in figure 2 (view A) is not maintained, the crankshaft will eventually fail.

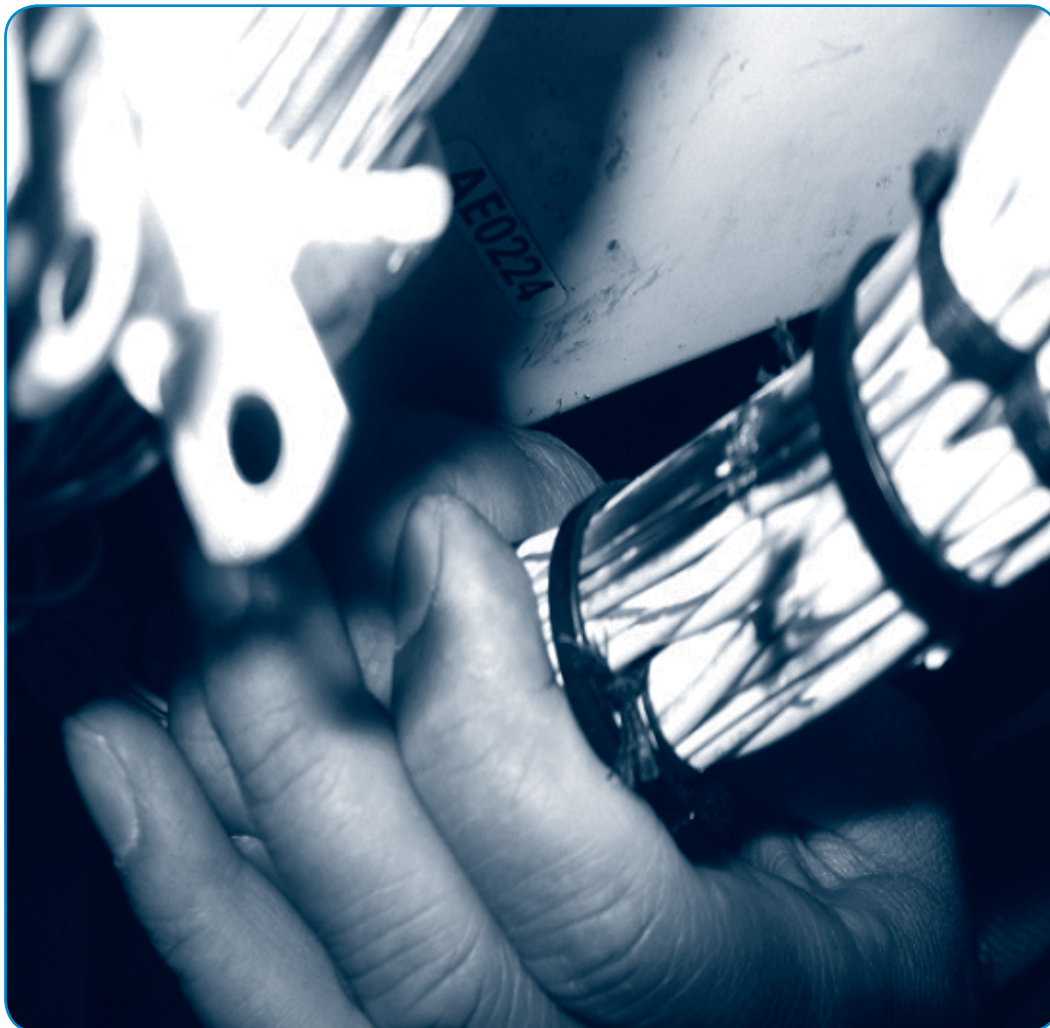
Sparks were noted emanating from an In-Flight Entertainment (IFE) wire bundle section below floor of a Boeing 767. This condition resulted in the tripping of circuit breaker TR-4. Further maintenance investigations found a wire arcing and shorting to a clamp due to its shielding being worn. The bundle was opened, repaired with a sealed splice per SWPM 20-30-12, then cleaned and inspected for further damage. Additional protection with tape per SWPM 20-10-13 was applied and a larger replacement clamp was used. The wire bundle was resecured; TRU #4 and Thales system checked serviceable per Thales AMM SUPP. 44-22-04.

*As aircraft technology advances and more electronic equipment is being used, such as this case with complex IFE systems, the essential requirement for diligence towards proper wiring practices is critical.*

*Always ensure harnesses are well supported through correct clamp sizes and proper shielding. ✖*

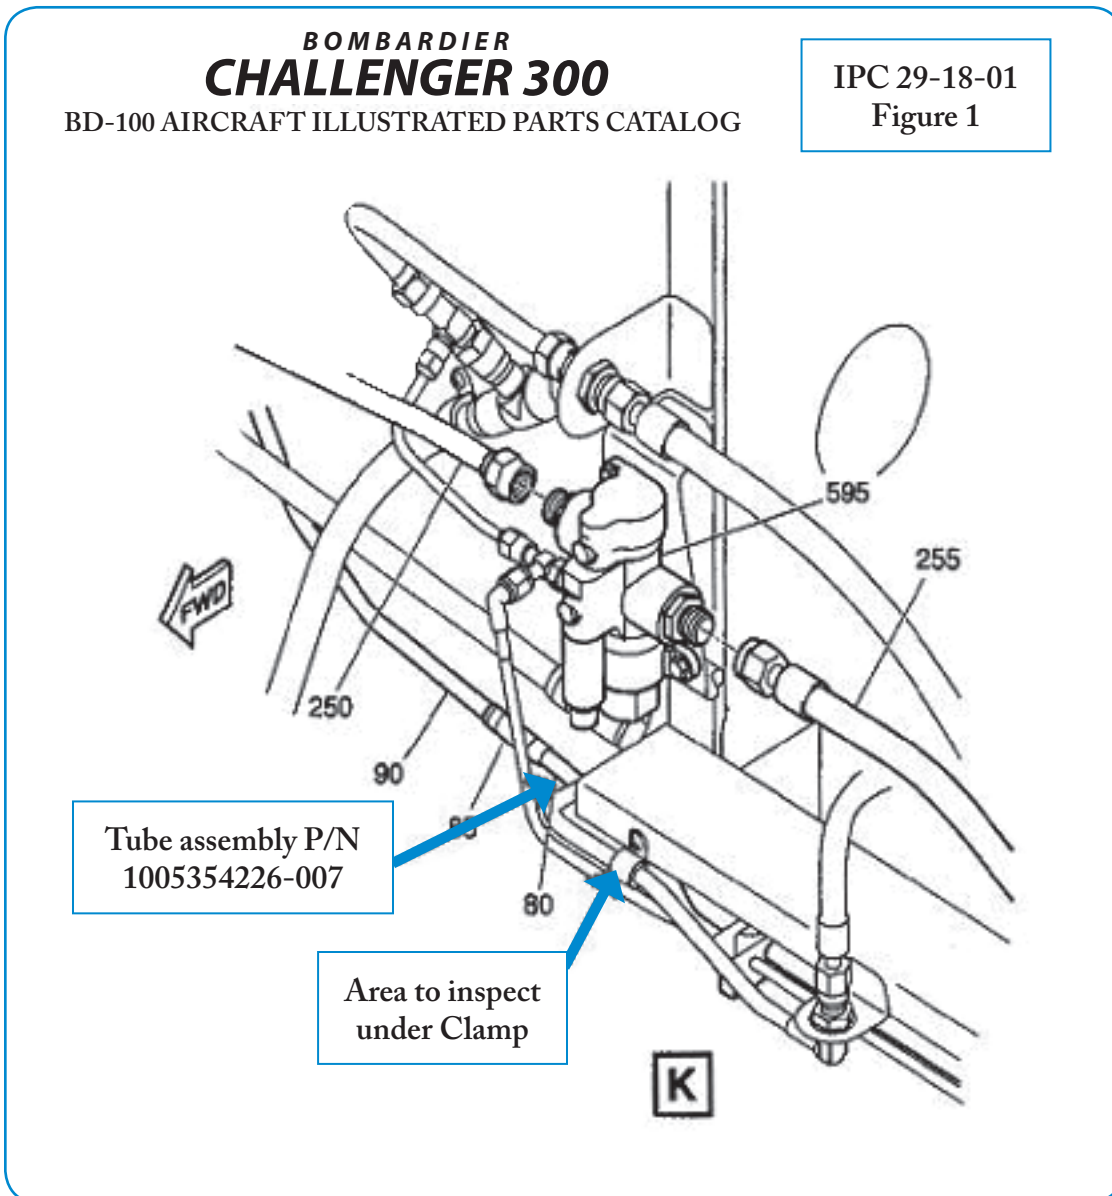
While in cruise flight, the amber (R HYD Press Low) Crew Alert System (CAS) message illuminated. Pilot observed the hydraulic synoptic page and noted the fluid level in the right hydraulic reservoir was dropping. Aircraft (ACFT) began descent. During approach, pilot noted the right hydraulic reservoir quantity was reading (4%). After landing, visual inspection of the ACFT revealed hydraulic fluid streaming from the wheel well area to the tail of the ACFT.

Maintenance found a hydraulic line in the aft equipment bay that had a hole in it caused by chaffing on a fairlead block.

*This is the second SDR received in 30 days for chaffing hydraulic lines in the same area. Proper protection and clearance will prevent line chaffing and prevent in-flight safety occurrences. ✖*

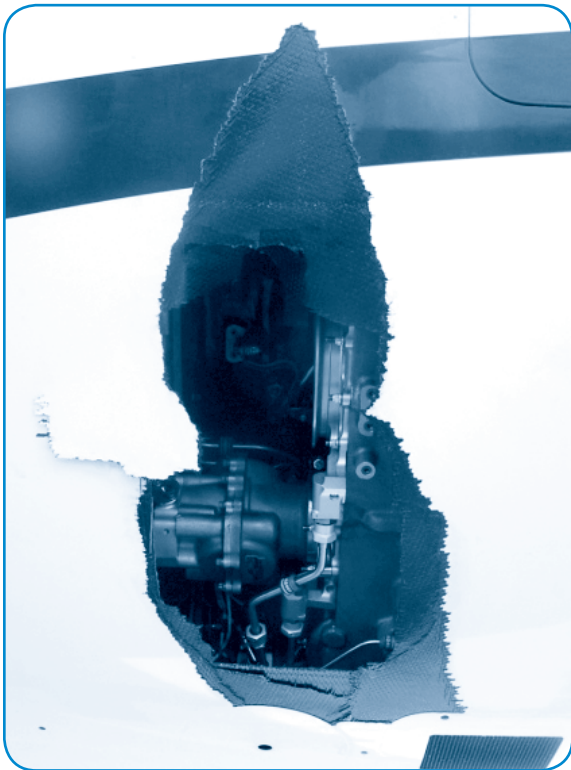
In cruise after 8 hours of flight, the aeroplane had a Variable Frequency Generator (VFG) #1 fail. The crew heard a loud bang followed by a "Gen 1 Fail" message on the Engine Indicating and Crew Alerting System (EICAS). A visual inspection conducted after landing confirmed that the L/H engine lower cowling had been punctured and the VFG sump casing was extensively damaged. Additional damage to the VFG #1 oil and the engine driven pump (EDP) drain line was found.

*This has been the second occurrence of this type of VFG rupture and failure since the introduction of the Global Express Aircraft.*

*Failure investigation has revealed that under cold conditions in flight, where the VFG oil viscosity is high, the cooling oil flow is reduced which can lead to rotor diode failure. This investigation has been linked to a recent change in oil filter element material with low oil flow at low temperatures.*

*Bombardier Aerospace has issued Advisory Wire AW700-24-0313 rev 8 and will continue to investigate this occurrence. ✖*

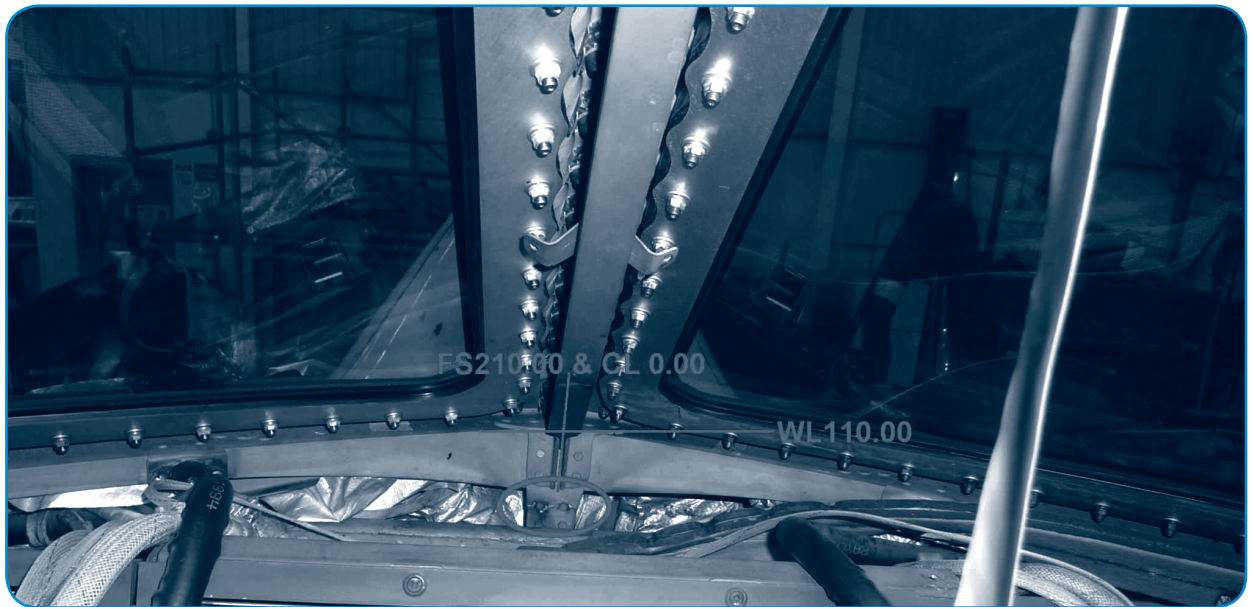
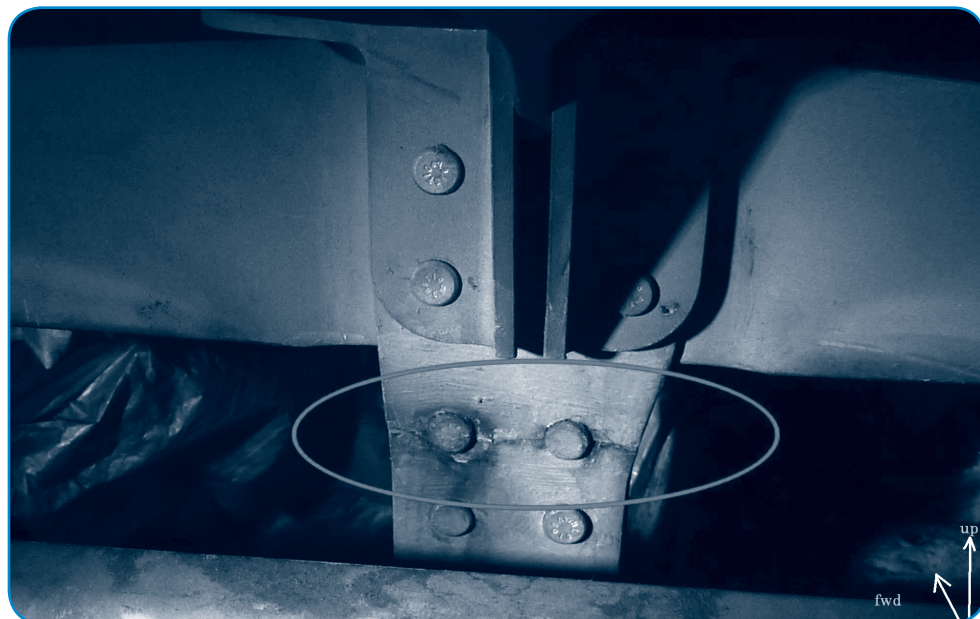
During a scheduled maintenance visit and completion of task RJ2-53-220-604, detailed inspection of a CRJ 100 windshield center post and bulkhead aft post at FS202.75, maintenance found the windshield center post lower forward strap cracked at FS210.00, CL0.00 and WL110. The post strap was repaired per drawing and Structural Repair Manual (SRM) and made serviceable.

*This aircraft had accumulated 32 300 hours of flight and 26 141 flight cycles when this crack was found during a 72 month inspection interval.*

*Transport Canada Civil Aviation would like to emphasize the importance for all maintainers to follow the required maintenance program that is defined by the manufacturer. ✖*

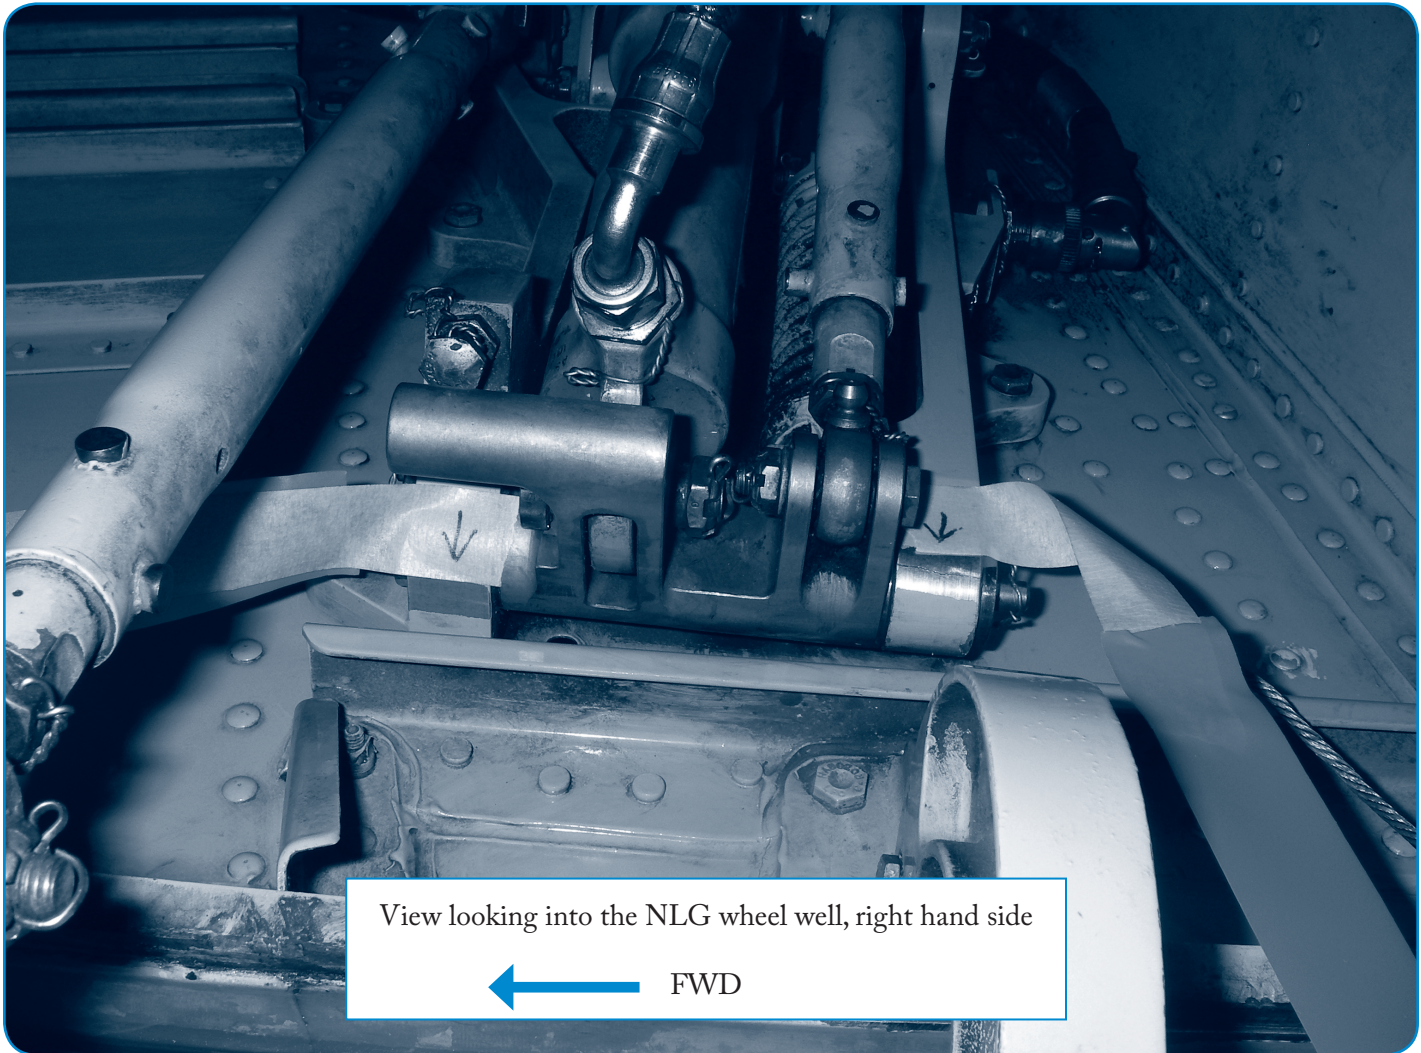
During a routine inspection, maintenance found cracks on the base of the nose landing gear door (NLG) actuator support mechanism, located in the NLG bay.

The cracks were at both the forward and aft lug pivot points for the lower lever pin. A new NLG door mechanism was ordered, the mechanism was replaced, functional tests were carried-out and the aeroplane was made serviceable.

*Further inspections on other aircrafts of the same model were done with no findings.*

*Through the close scrutiny of the mechanic involved, a potential NLG gear door failure and possible operational interference was averted. ✖*

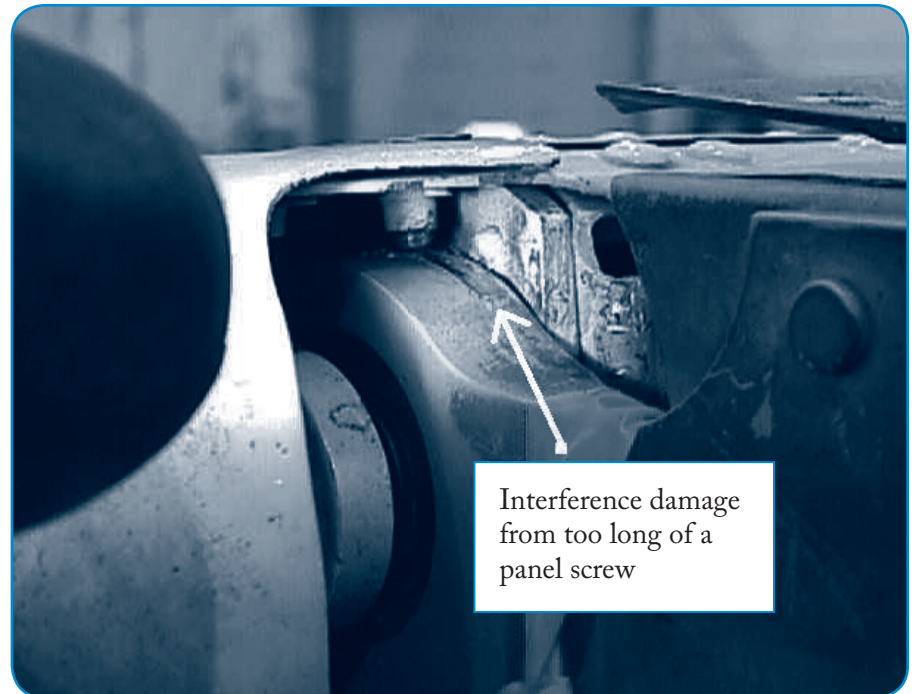
Upon removal of elevator panels to facilitate inspection; it was discovered that the R/H elevator hinge fitting was grooved/gouged on the top radius of the fitting. It was apparent that the gouging was caused by one of the panel screws that attach the R/H elevator end cap fairing was too long. When the elevator controls were moved, the screw would continue to wear a groove in the fitting. It was later determined that incorrect screws were installed (too long) in the upper elevator access panel.

*Over a period of time, the structural integrity of the elevator fitting could be degraded. As a result, it would be an ideal condition for stress corrosion and possible failure of the elevator fitting. ✖*

The Convaair parts catalogue calls for an AN509-10-R7 screw; the rest of the fleet will be inspected for similar condition and rectify as necessary.

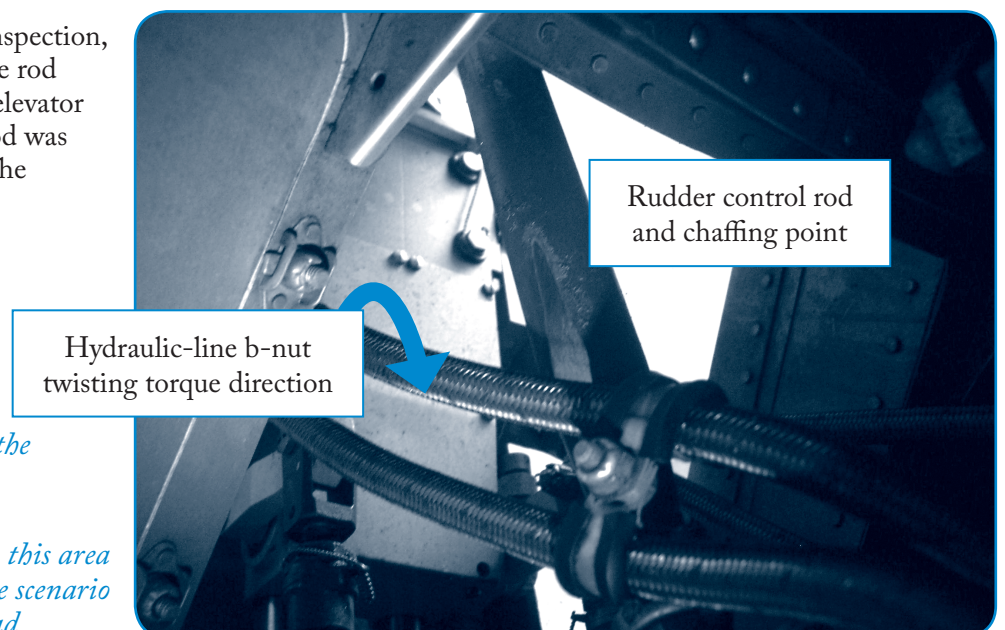
During a scheduled maintenance inspection, the rudder push-pull non-adjustable rod was found chafing hard against an elevator servo hydraulic pressure line. The rod was replaced with serviceable unit and the lines repositioned.

*It is suspected that the elevator servo pressure line was improperly tightened in a manner that allowed it to twist and in-turn causing it to chafe on the rudder push-pull tube.*

*Transport Canada Civil Aviation recommends that when working in this area to pay close attention to this possible scenario and to always ensure not to pre-load hydraulic lines during installation. ✖*

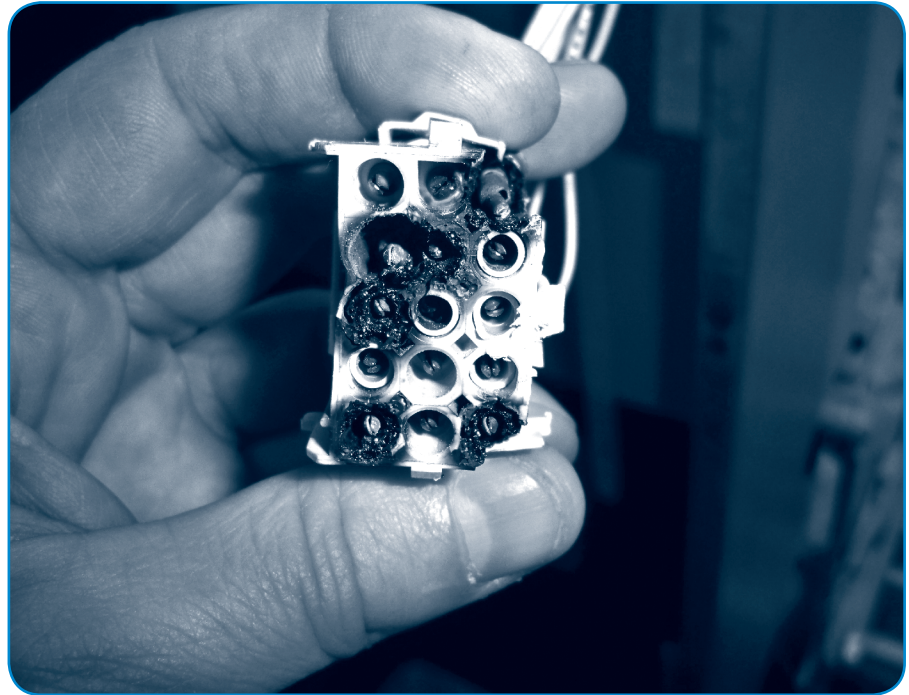
During a major inspection, the L/H overhead light connector 3320-P40 and receptacle 3320-J35 were found severely burnt.

*It is unknown what caused this extensive damage; however, connectors have been particularly vulnerable to condensation in the past, due to condensation within the shell. Special connectors with waterproof features have been developed for use in high humidity areas (e.g. cabin overhead ceiling areas). ✖*

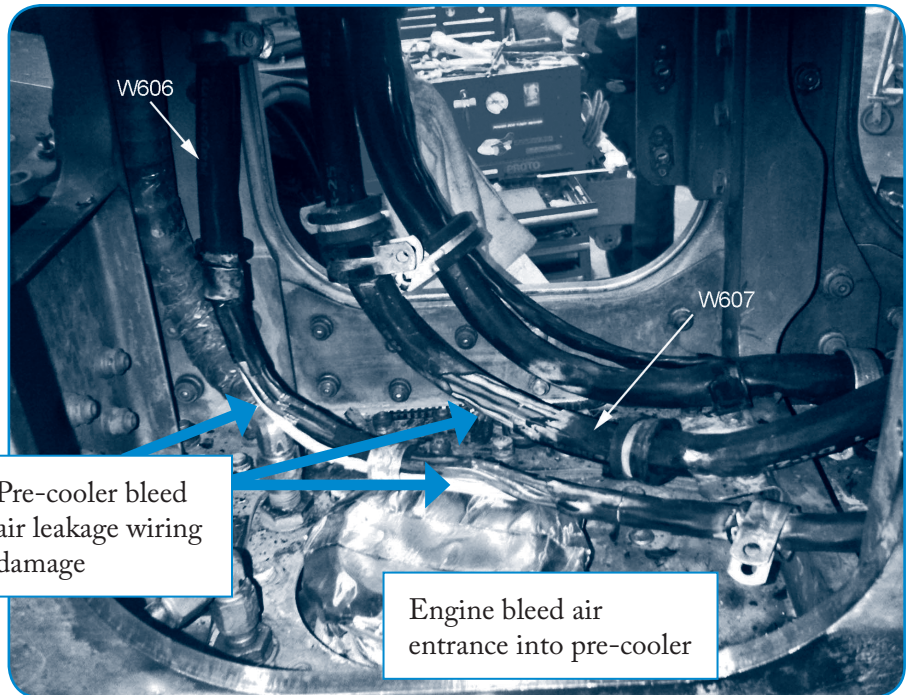
While maintenance was performing a scheduled inspection task within the right engine pylon, wiring harnesses W606 and W607 including some adjoining clamps were found with heat damage from a hot air lead at the pre-cooler.

*The pylon harnesses that are being damaged by the pre-cooler engine bleed air leakage provide various engine control and monitoring functions.*

The wire harnesses were repaired as per the standard wiring practice manual (SWPM) and the pre-cooler gasket was replaced and the aeroplane was returned to service.

*Transport Canada Civil Aviation is presently working with Embraer Continuing Airworthiness to correct the pre-cooler bleed air leakage fault in-order to decrease the possibility of damaging pylon-wiring harnesses. ✖*

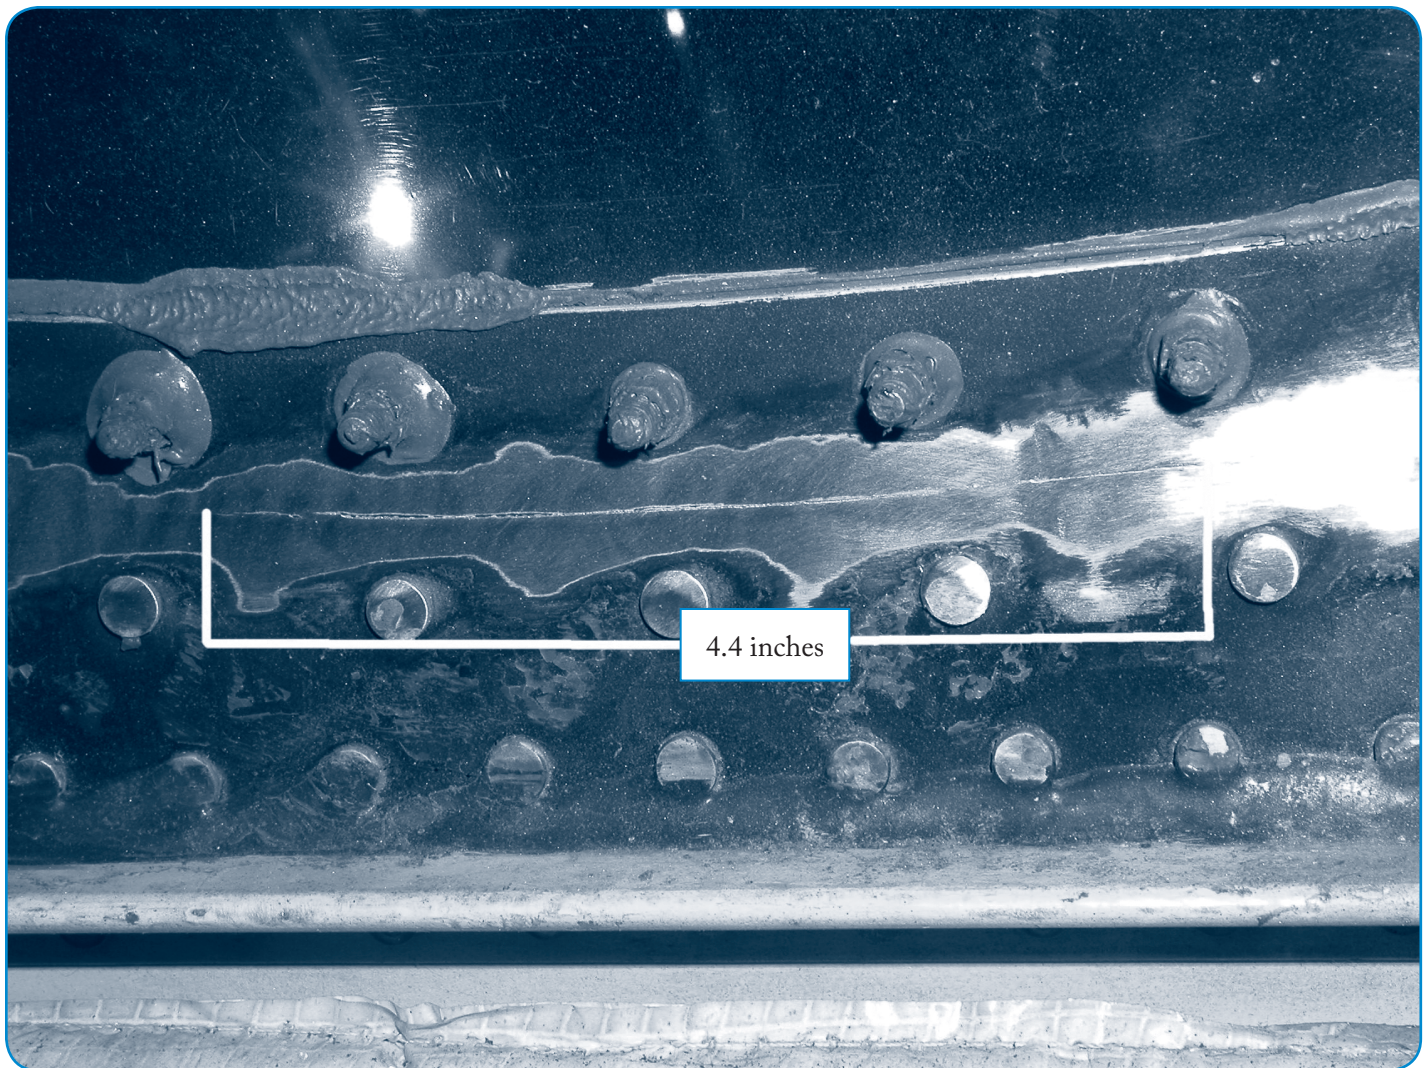
The aeroplane was undergoing a cabin inspection for window frame fastener corrosion when maintenance found a crack in R/H #4 window inner retainer. The crack measured 11.176 cm (4.4 inches) running between and parallel to the 2 rows of fasteners at the lower edge of the retained.

*This retainer is the only structure attaching the window assembly to the fuselage and if the crack was*

*Recently at the last revision, maintenance inspection tasks were added in the Maintenance Planning Manual (MPM) to detect this type of failure.*

The window structure was repaired and the aeroplane was returned to service.

*Transport Canada Civil Aviation would like to ensure that all owners and operators are aware of this possible scenario and of the new maintenance inspection tasks available. ✖*

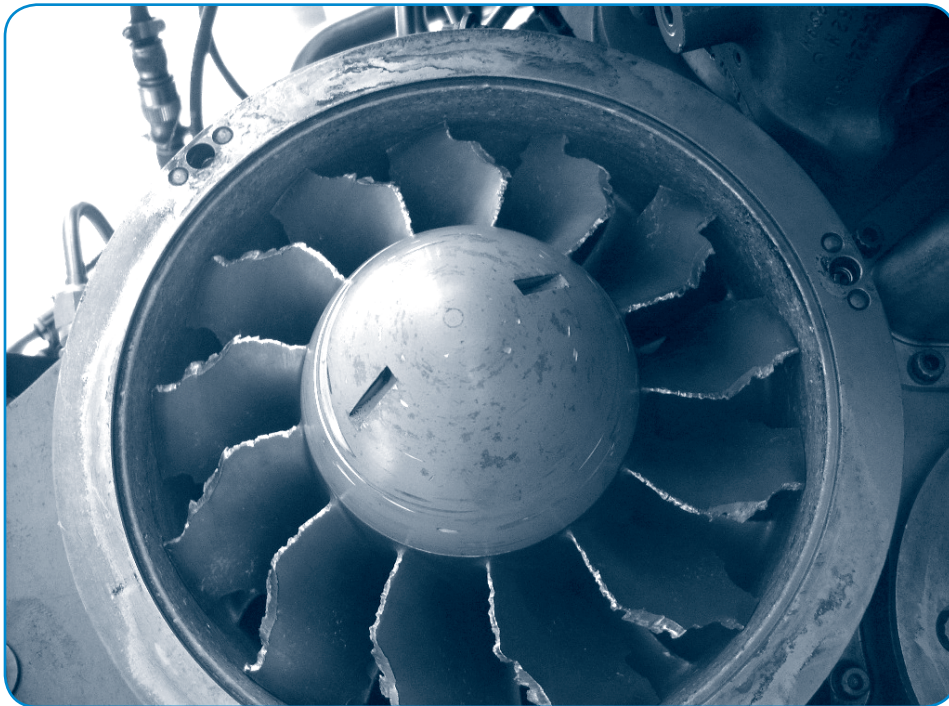
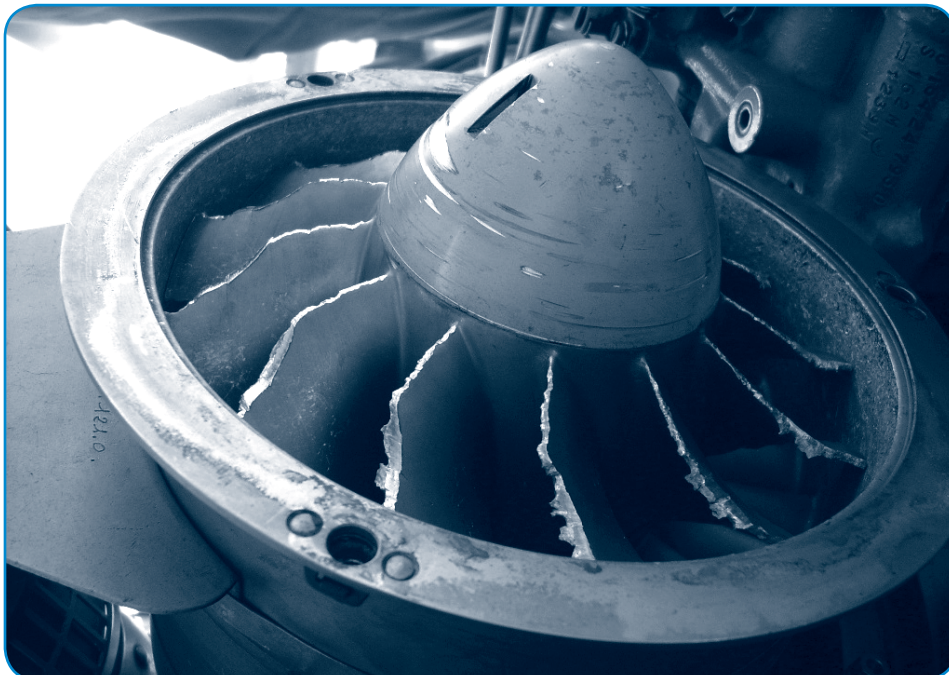
Pilot was taking off from base, reported hearing odd whining from engine during takeoff and power changes. Aborted takeoff and returned to staging area. Opened engine cowl, noted aluminum shavings on engine deck. Visual inspection identified the compressor wash union Part Number (P/N) 350A54-1112-20 welded boss on intake assembly P/N 350A54-1080-04 had broken off

and become ingested into the engine. Aircraft had been subject to scheduled inspection less than 10 hours prior, with no defects noted at that time. Aluminum shavings from welded boss were found ejected out of the bleed valve and out of the exhaust. The steel union did not get ingested, but bounced around in the intake plenum causing substantial damage to the axial compressor. ✖

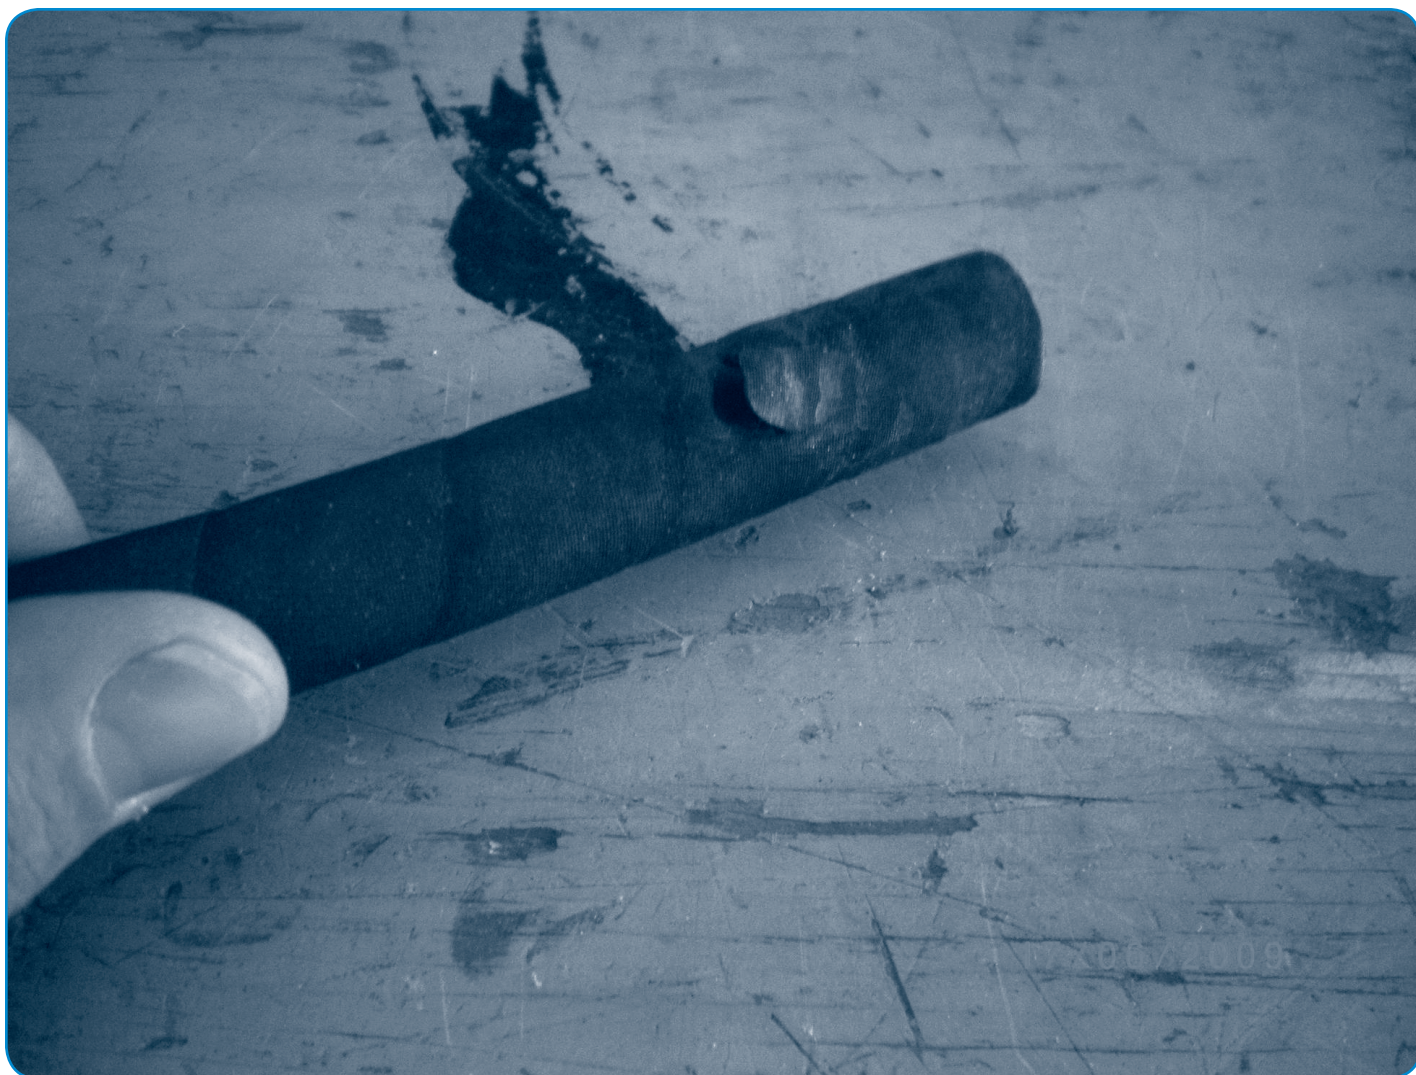
During an aircraft ground run, while performing a leak check on the aircraft, the AME discovered a fuel leak coming from the fuel cap location and discovered that the leak was from the transmission deck. The fuel line hose was found cut from the fitting and spraying fuel inside the transmission compartment.

The ground run was discontinued and the fuel hose replaced.

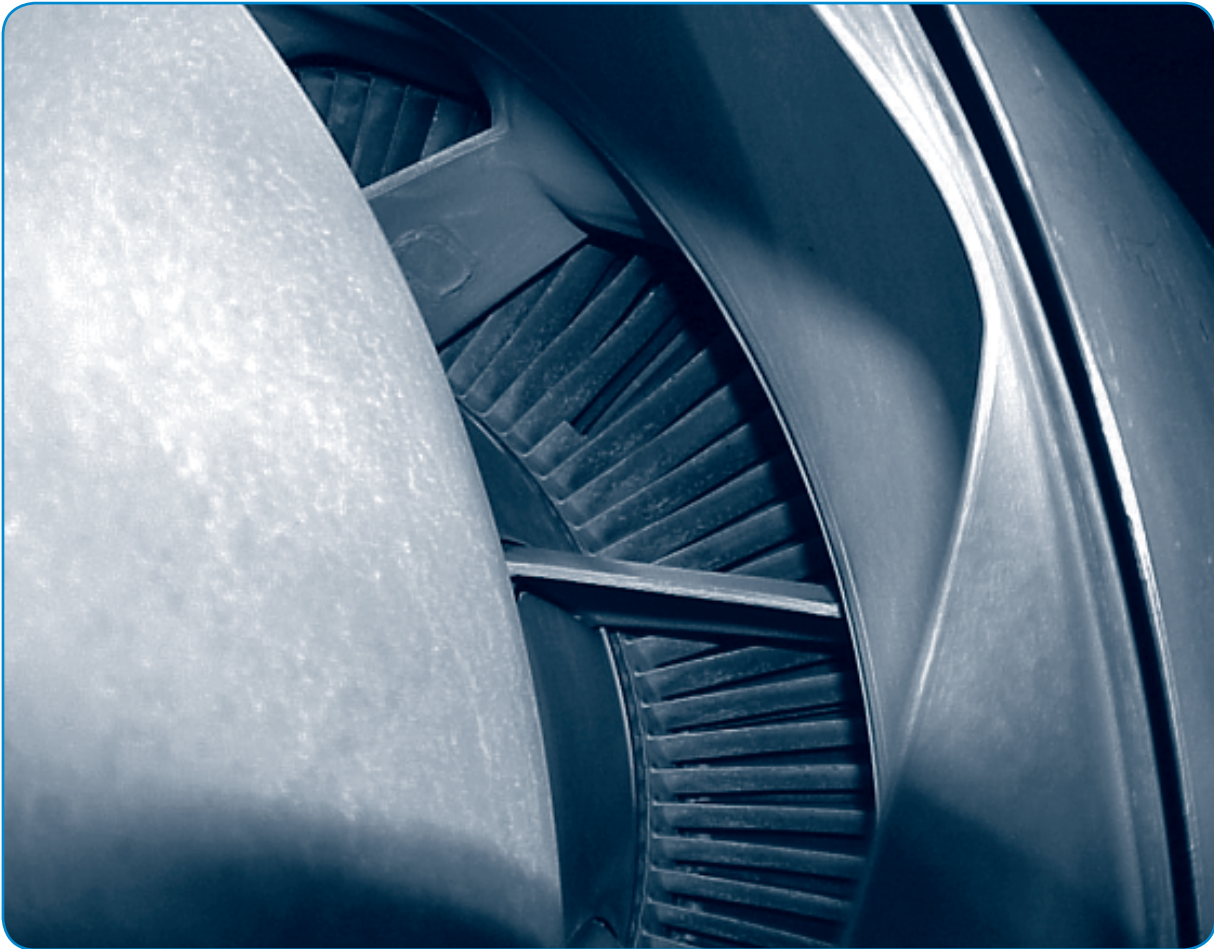
On the ground during visual inspection the last stage turbine was found severally damaged.

*General Electric (GE), the manufacturer of this engine, has completed a root cause analysis of this industry problem and has determined that it is due to low-pressure turbine (LPT) stage 4 blade tip shroud interlock wear, which causes vibration and high cycle fatigue of the blade. It is expected that GE will issue a service bulletin for an on-wing repeat inspection with pass/fail criteria for the blade tip interlock wear.*

The engine was replaced and the aeroplane made serviceable.

*Transport Canada Civil Aviation would like to emphasize the importance of a complete maintenance inspection for all cases of engine vibration exceedances, with particular attention to the last turbine stage for this engine type. ✖*

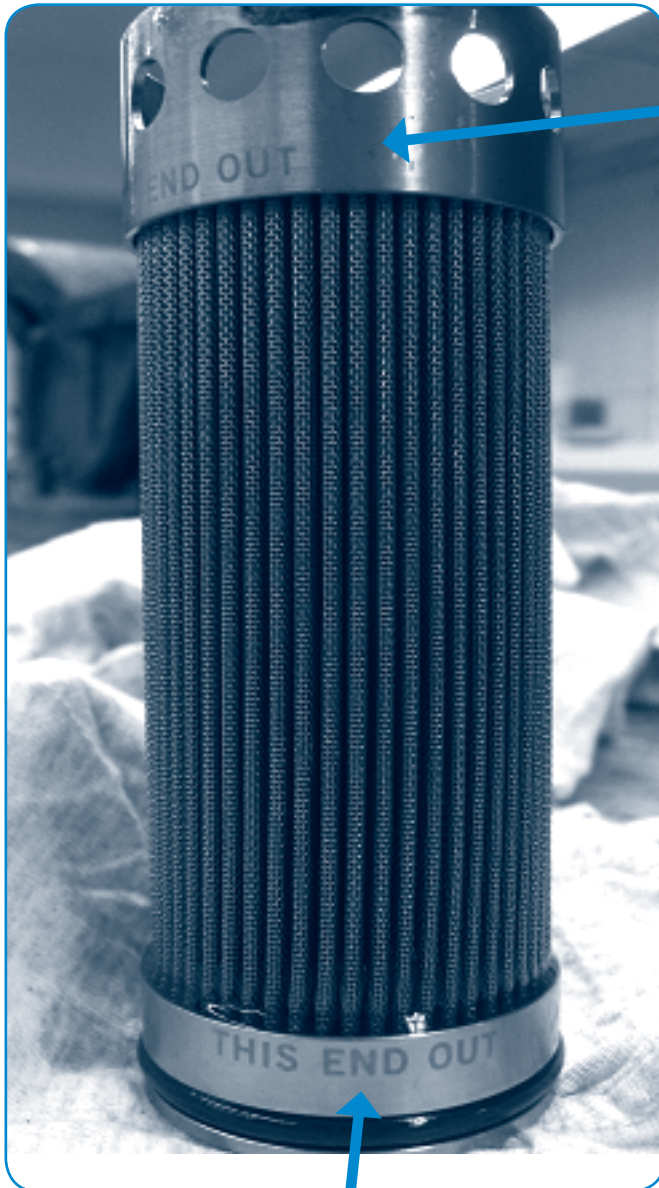
**Improper labeling**  
Reads “THIS END OUT”  
Should Read  
“THIS END IN”

**Proper labeling**  
Reads “THIS END IN”

*Transport Canada Civil Aviation recommends checking this at the next oil filter inspection and to always refer to the Maintenance Manual and to the Illustrated Part Manual. ✖*
