TEST REPORT

**Study of Frost /Dew Cover on Precision
Approach Path Indicators (PAPI)**

Contract No. 5113

TP 13705E

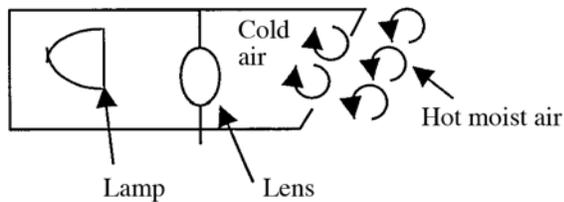
FIGURE 1:

*Because of the internal baffles used in the construction of the Cegelec PAPI unit, air circulated in front of the unit keeping the moist air out, (see drawing below). A longer time was required for frost to accumulate on the lens of the Cegelec PAPI as compared to the PAPI manufactured by Crouse-Hinds.

All units accumulated frost on their lenses or cover glass. The lens of Crouse-Hinds PAPI frosted in advance of the lens of Cegelec.

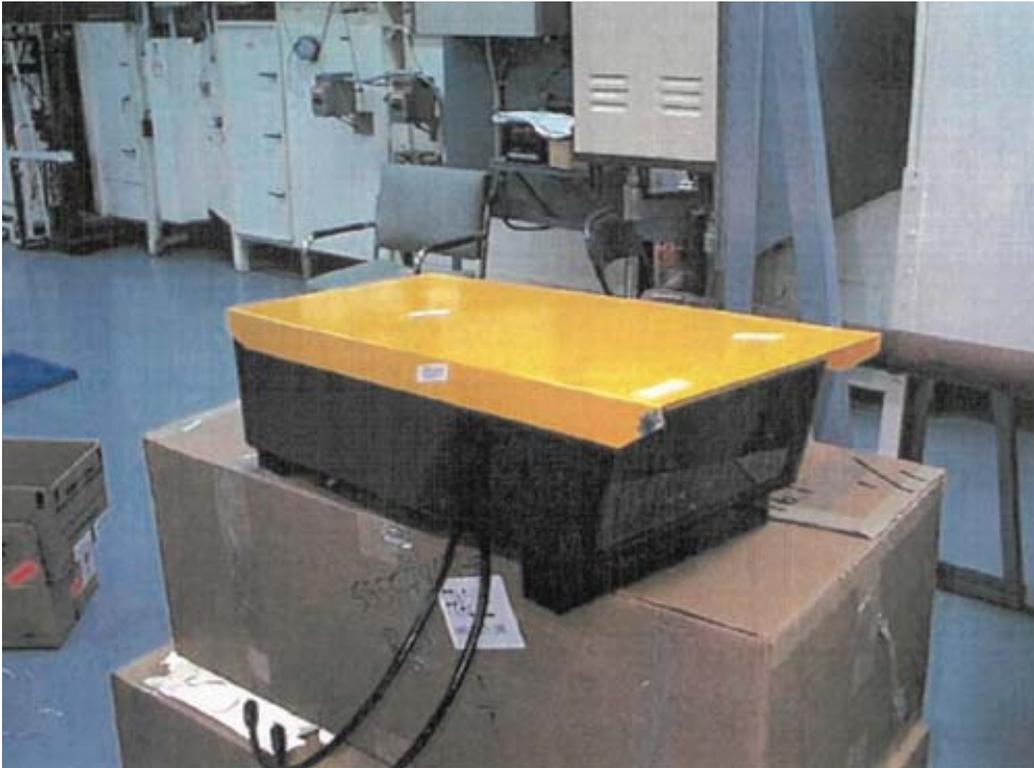
1. ADB/Siemens Papi.

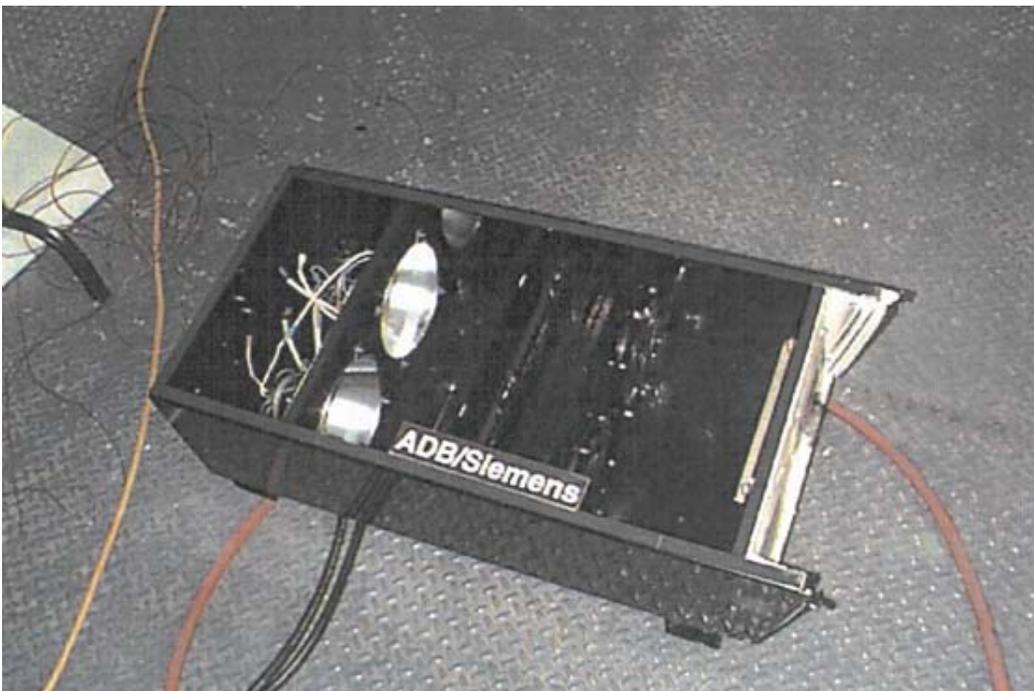
2. Inside view of ADB/Siemens.

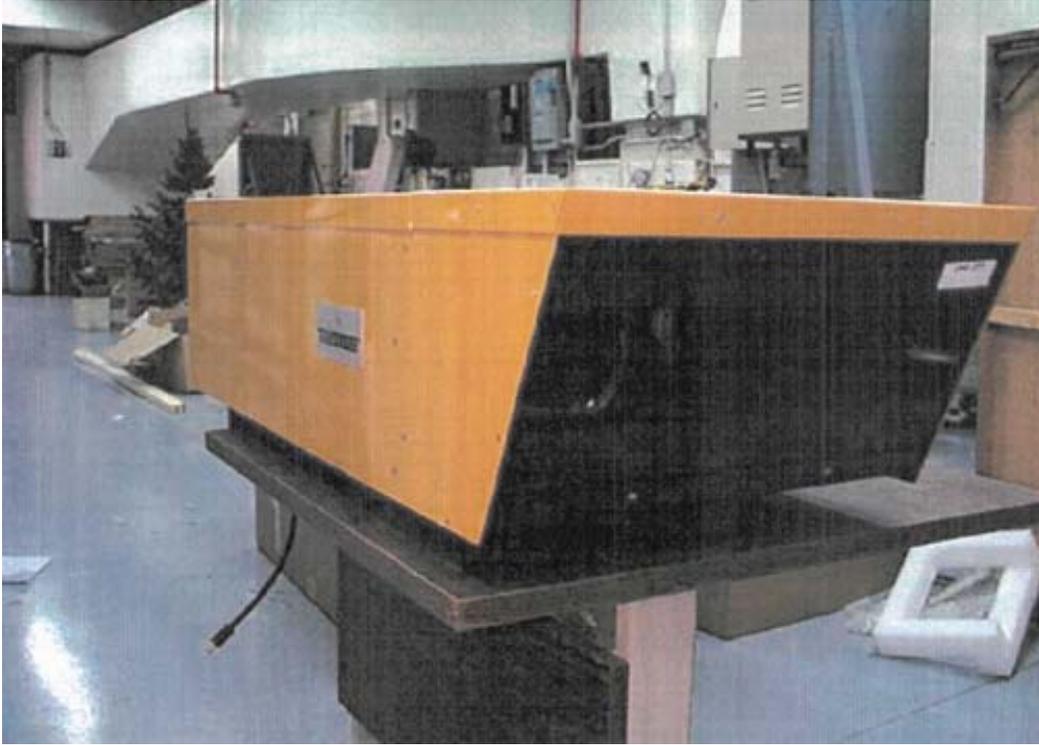
3. Cegelec Papi.

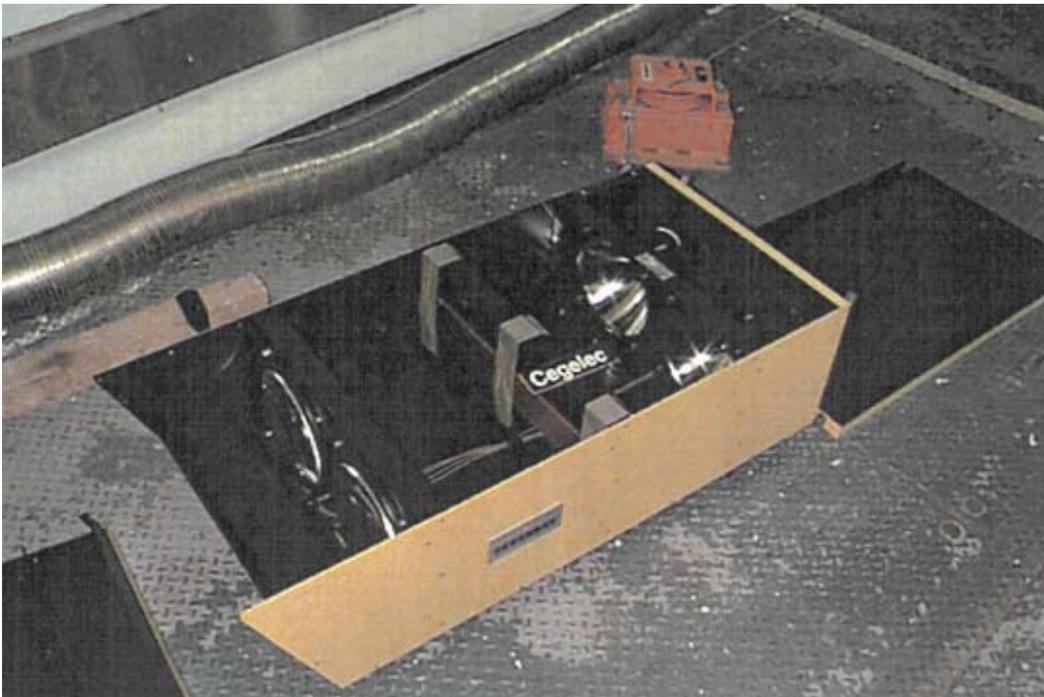
4. Inside Cegelec.

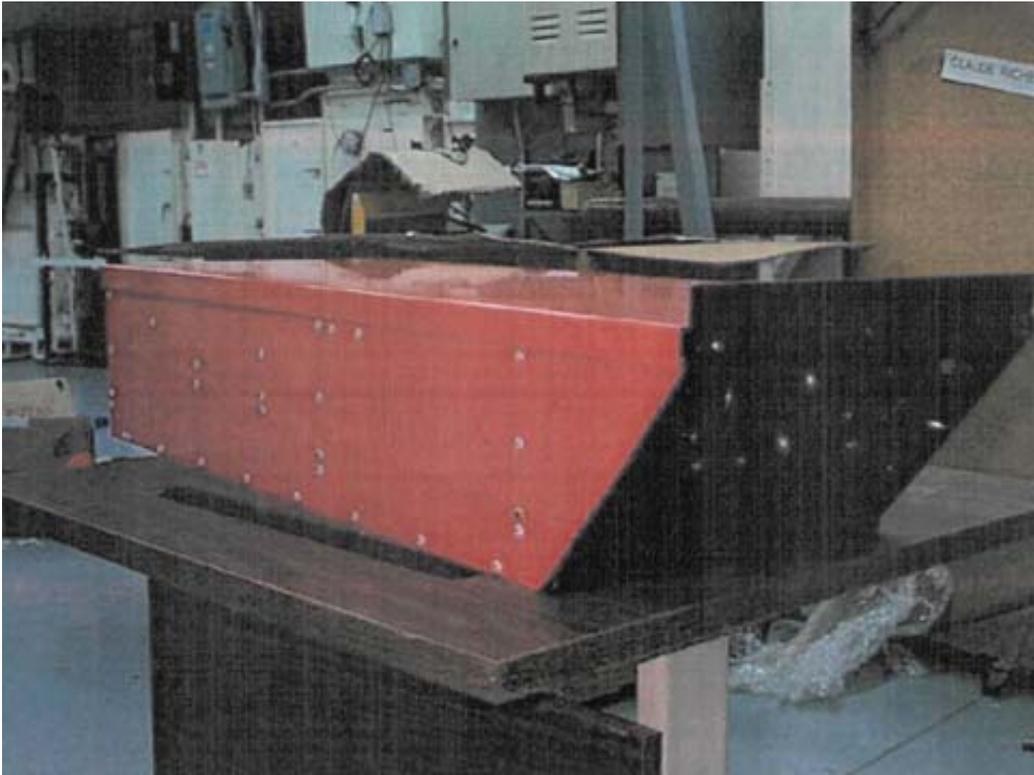
5. Crouse-Hinds.

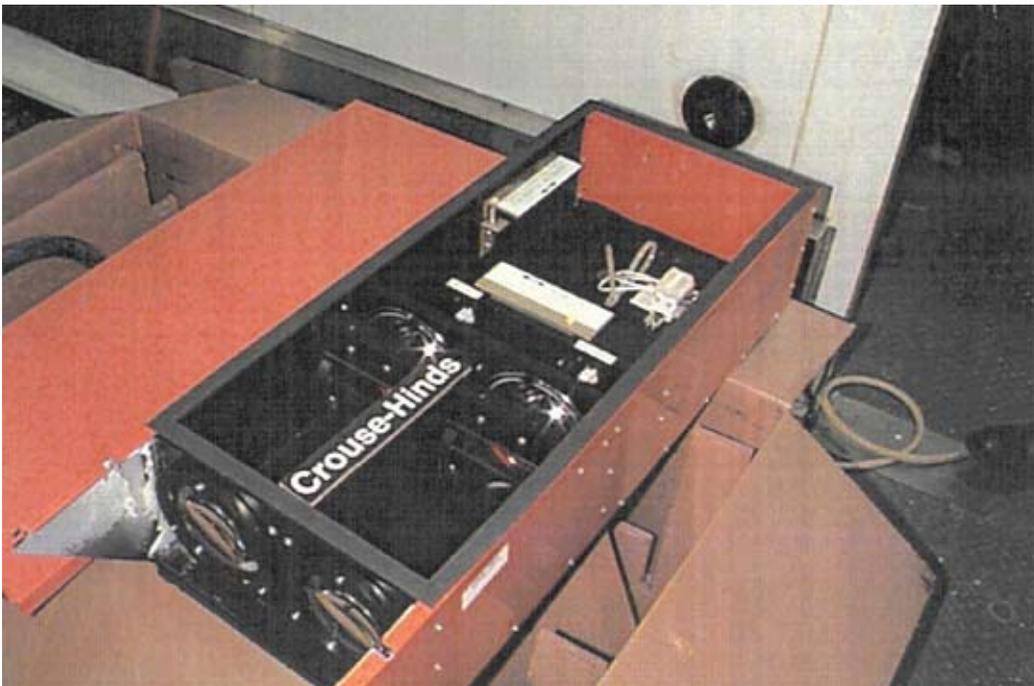
6. Inside Crouse-Hinds.

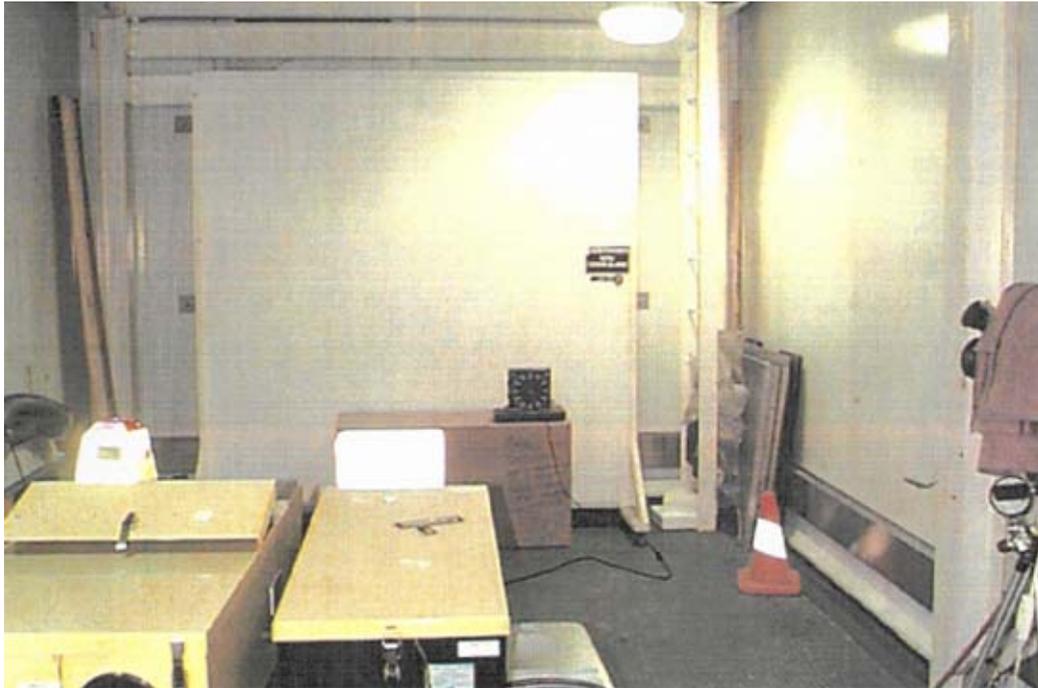
7. General view of the test set-up.

- 4.3.3 Arrange the units so that their signal is projected onto a white non-spectral screen at a distance of at least 3 m.
 - 4.3.4 Apply an equal layers (thickness) of frost on the front of each PAPI light unit.

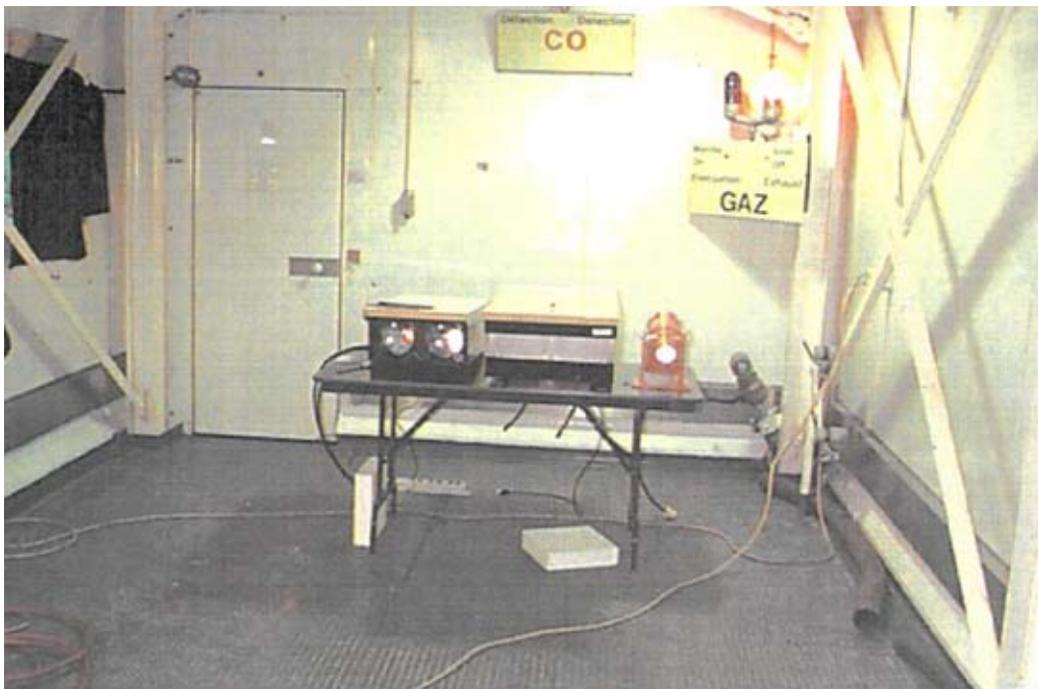
8. Papi installation

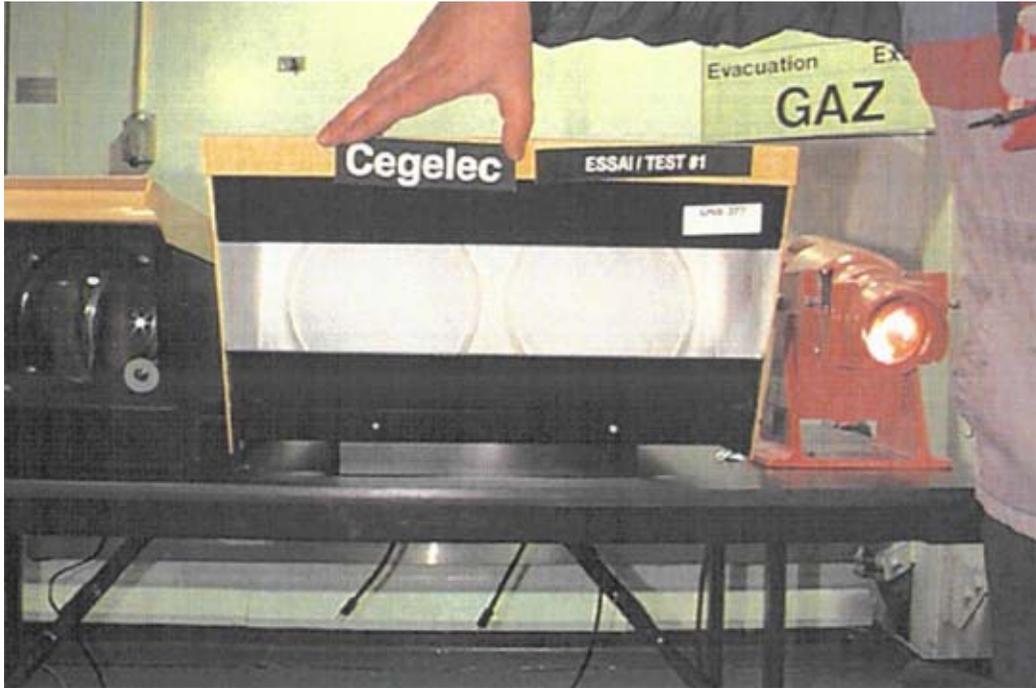
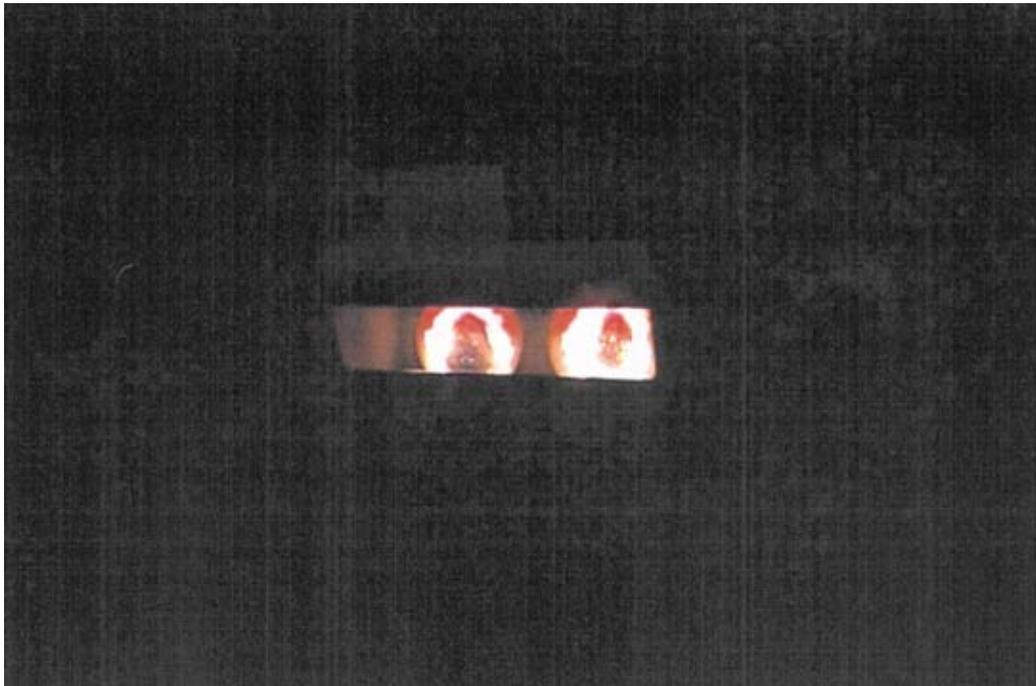
9. Test #1, pre-test.

10. Test #1, post-test.

Test #	PAPI Manufacturer	Cover glass (Yes/No)	Ice Thickness (inch)	RMS Current (Amp)	Defrosting time (min.)
1	Cegelec	N/A	0.060	6.60	56
2	Siemens	Yes/Antifog	0.055	6.60	25
3	Downing	N/A	0.060	N/A 120 V	Not defrosting
4	Siemens	Yes/Wired	0.060	6.60	3
13	Crouse-Hinds	N/A	0.055	6.60	8
14	Siemens	No	0.060	6.60	>30, no improvement after 20 minutes *

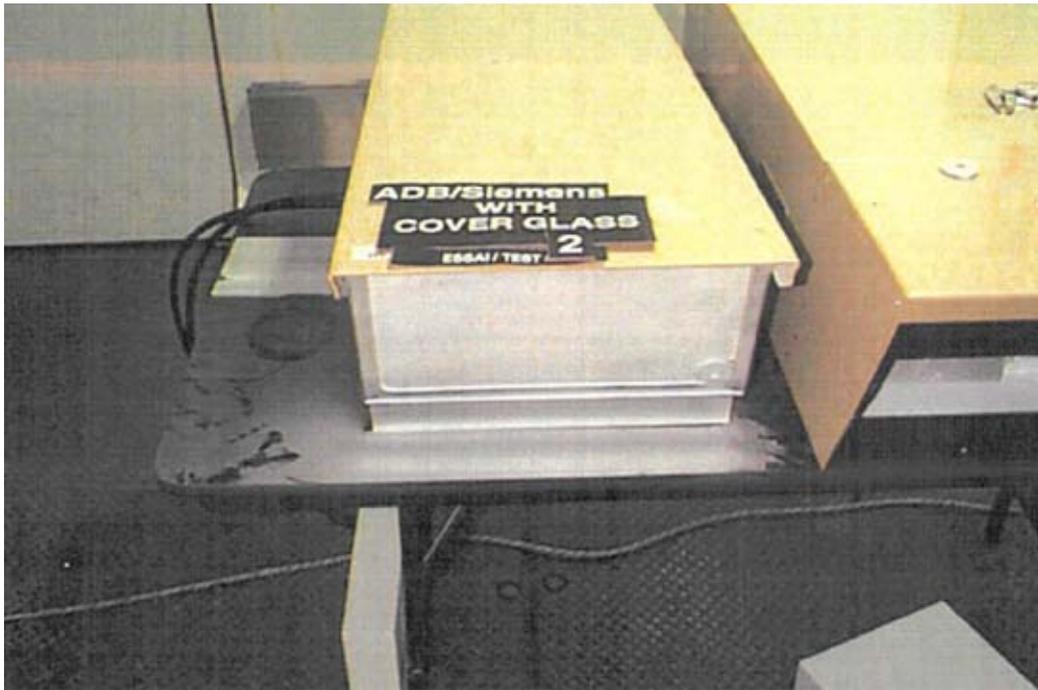
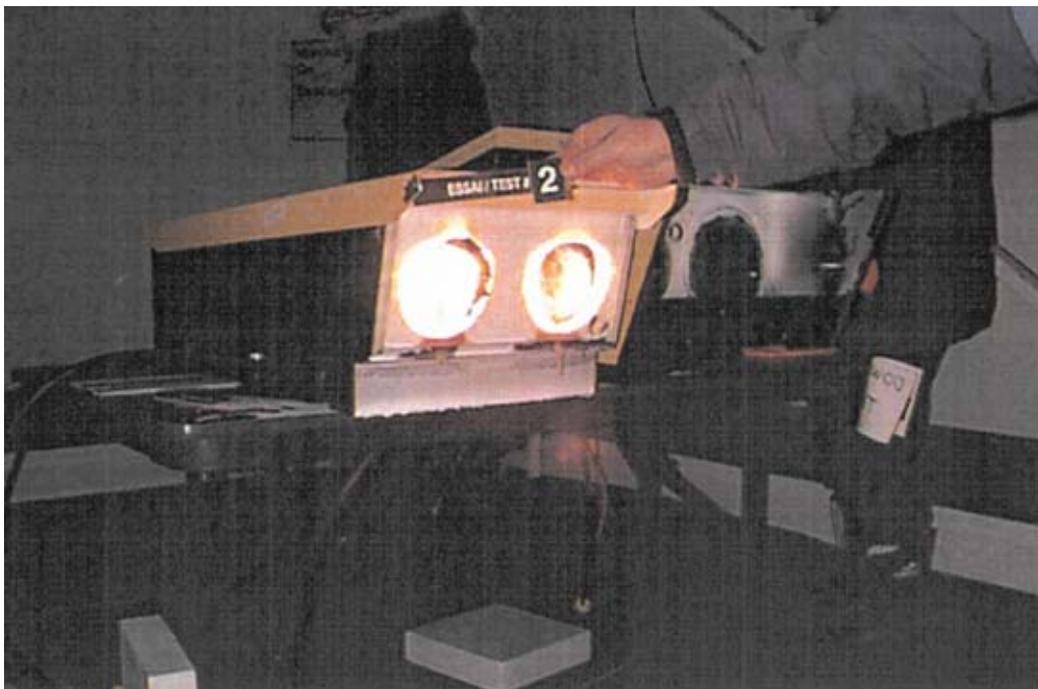
11. Test #2, pre-test.

12. Test #2, post-test.

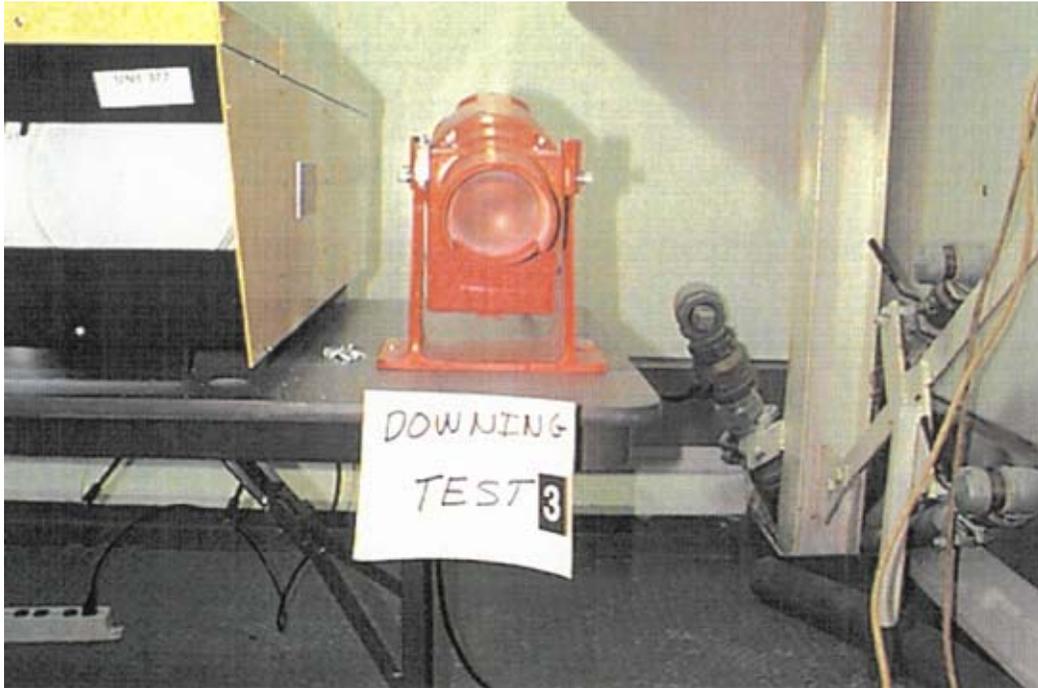
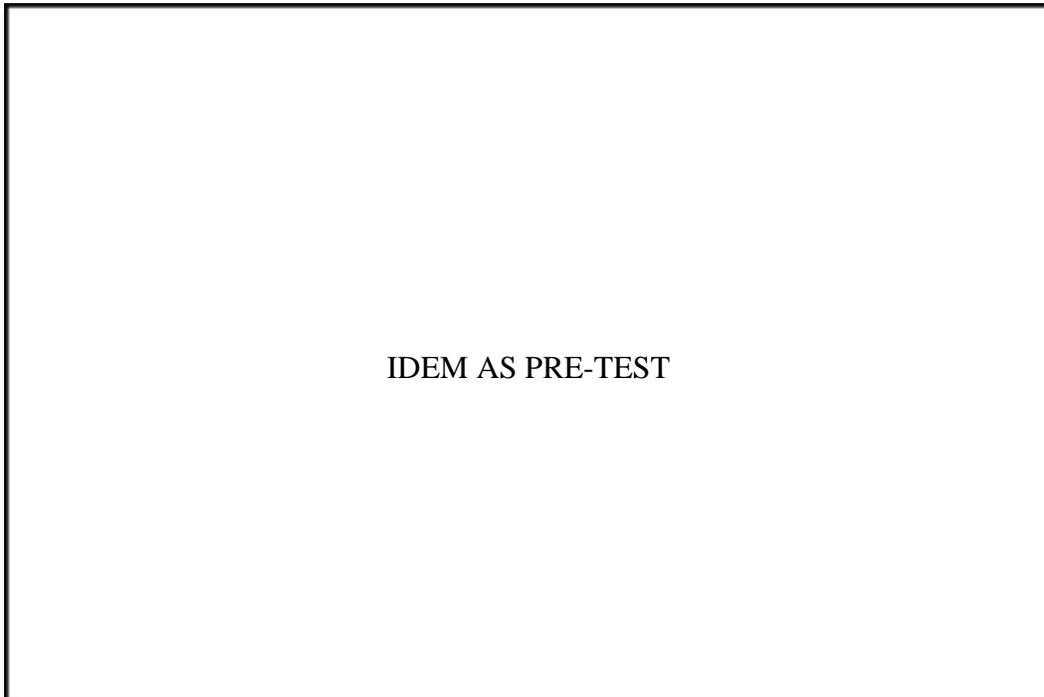
13. Test #3, pre-test.

14. Test #3, post-test.

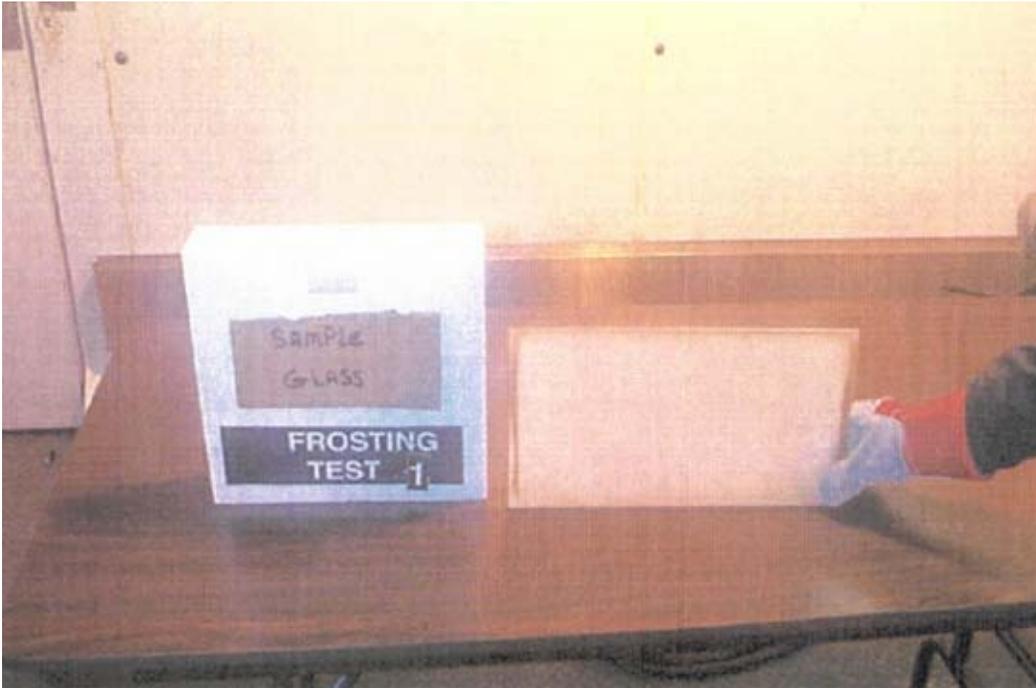
1. Sample glass frosting test #1.

Test #	PAPIManufacturer	Frost on lens (Yes/No)	Frost on cover glass
1	Sample glass	N/A	Yes, both sides
2	Crouse-Hinds	Yes	N/A
3	Cegelec	Yes, less than Crouse-Hinds*	N/A
4	Siemens	N/A	Yes

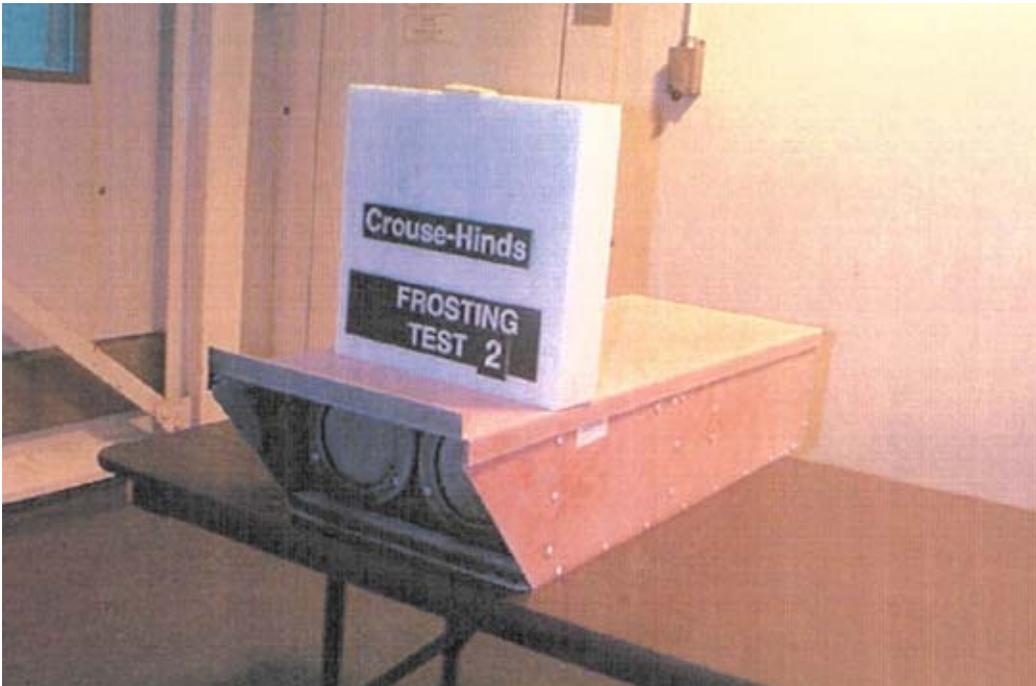
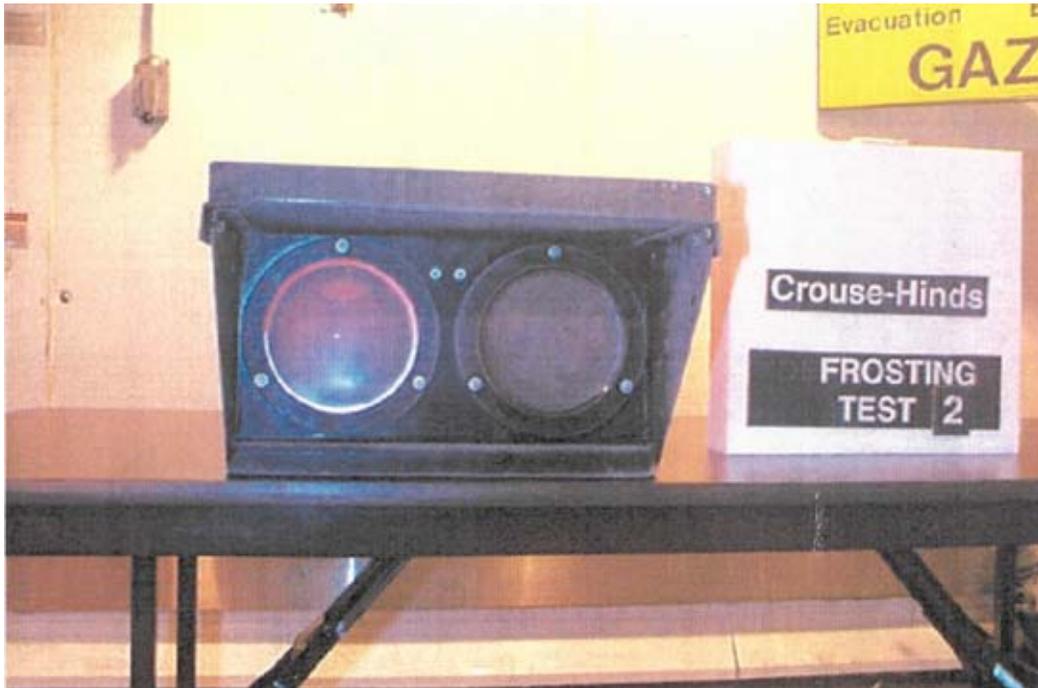
2. Frosting test #2.

3. Frosting test #2.

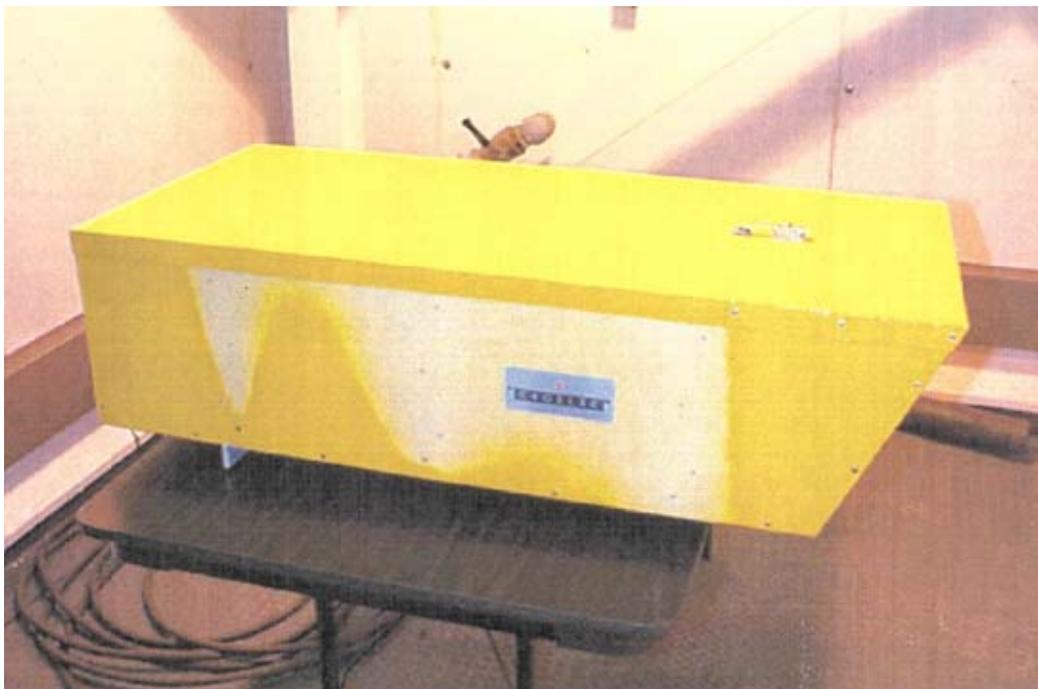
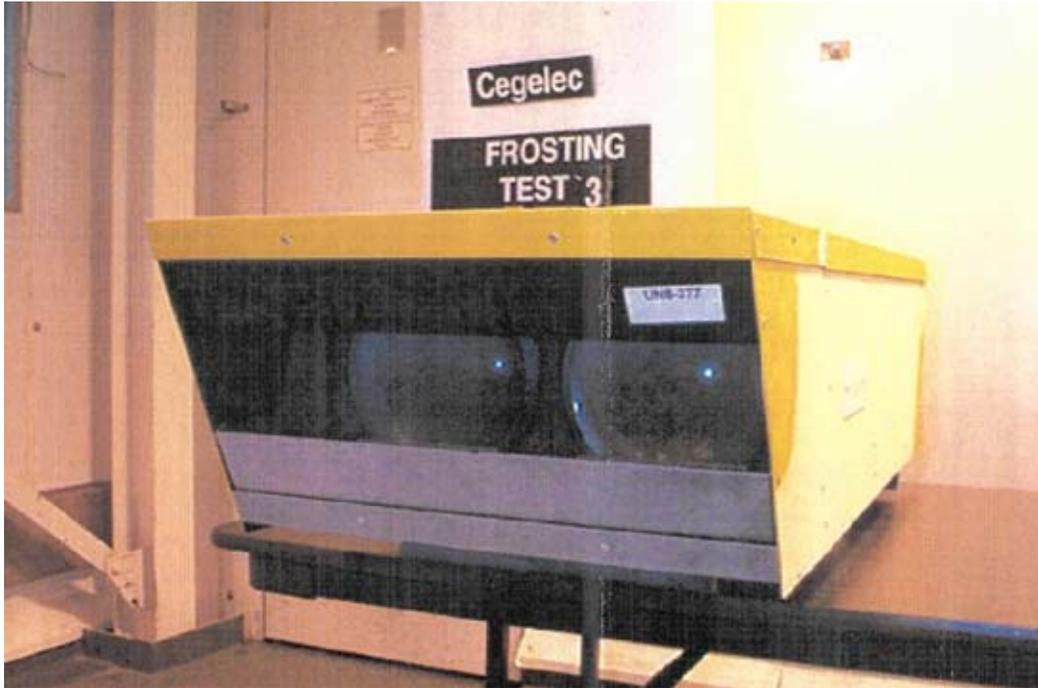
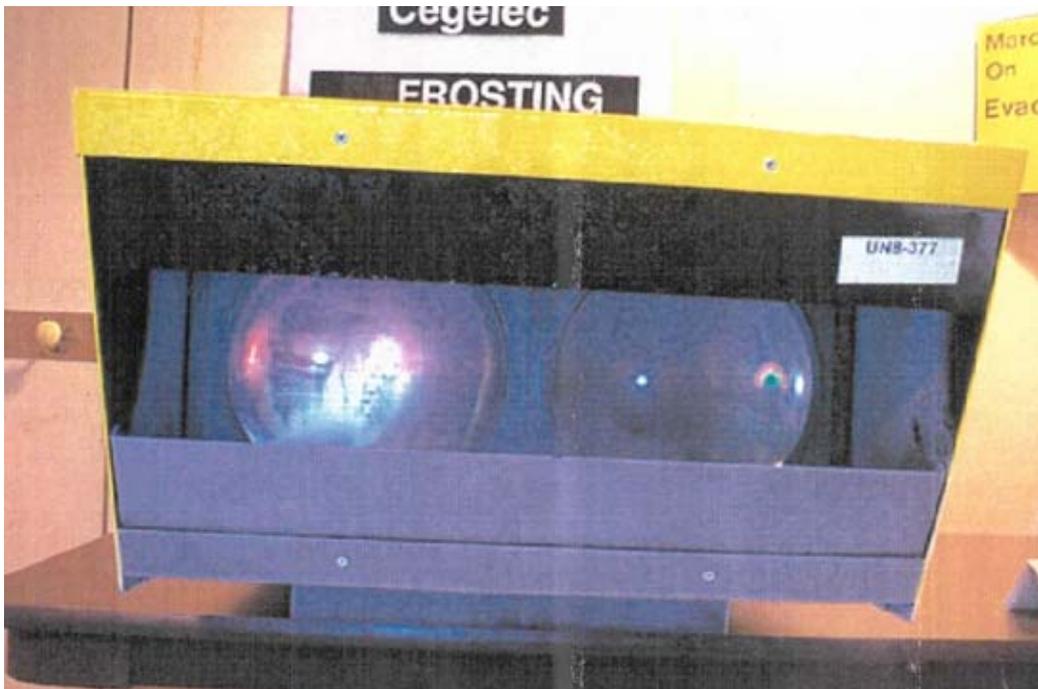
4. Frosting test #3.

5. Frosting test #3.

6. Frosting test #3.

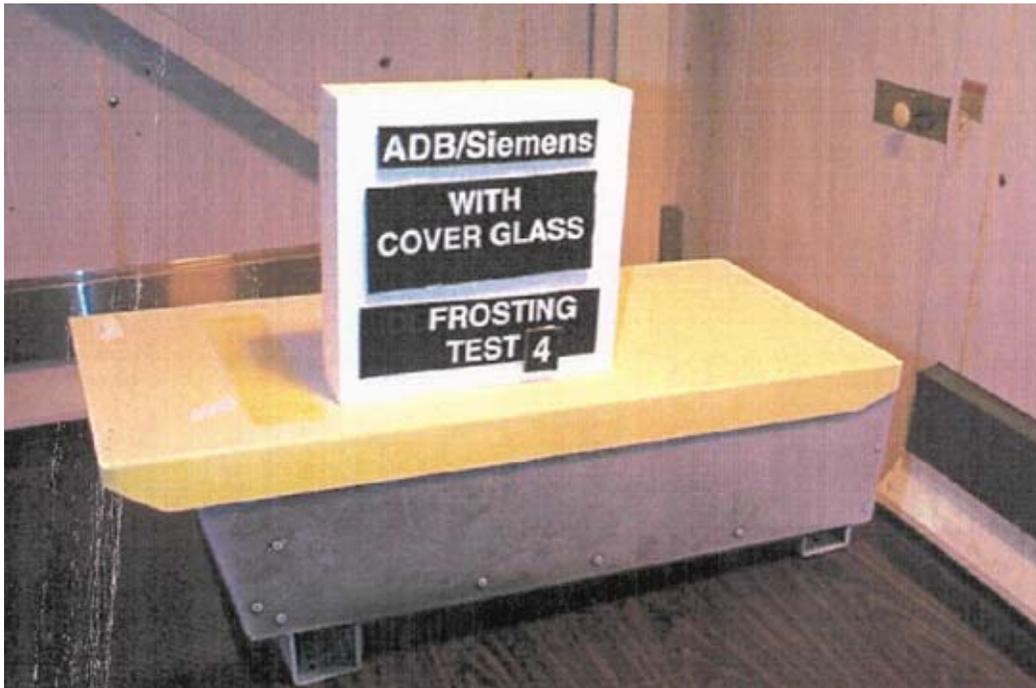
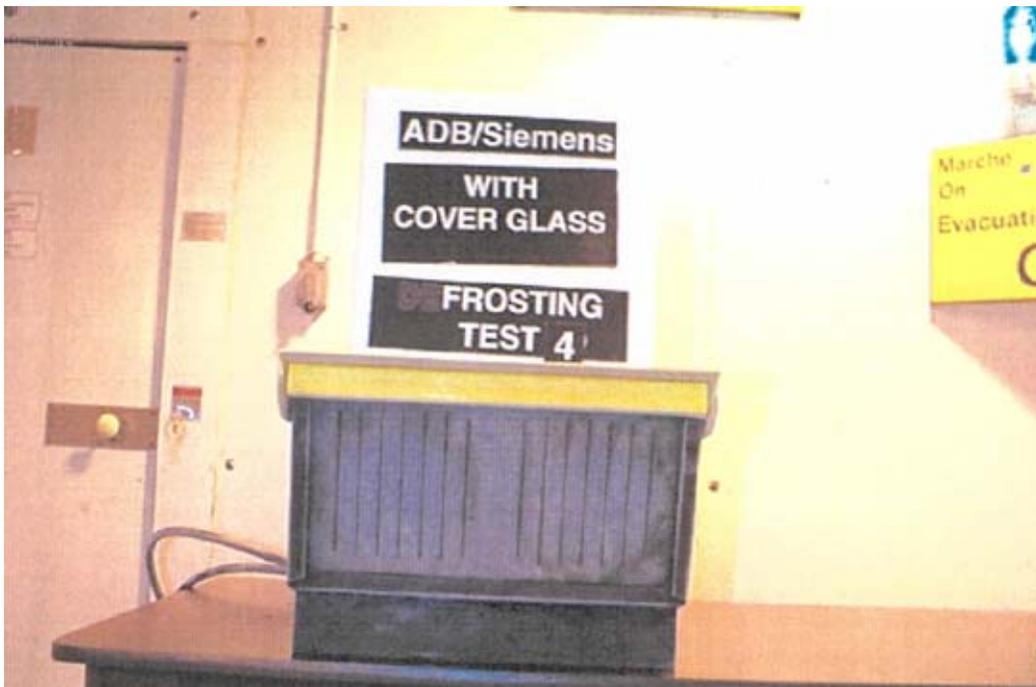
7. Frosting test #4.

8. Frosting test #4.
