TP 6980E
(09/2010)

Issue 3/2010

Canadian Aviation Service Difficulty Reports

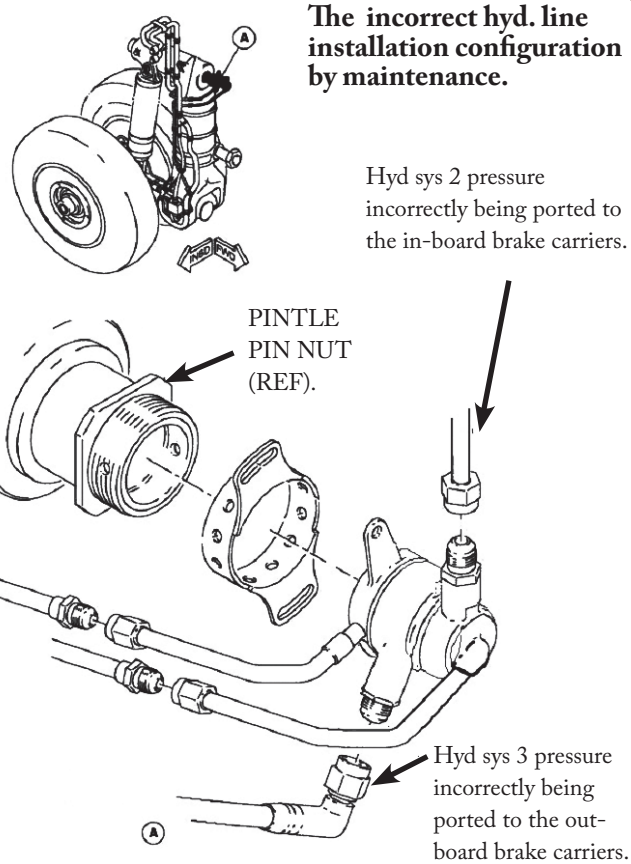
During a heavy maintenance visit, while performing brake system bleeding, maintenance personnel found that hydraulic system No.2 was actuating the in-board brake carriers and that hydraulic system No.3 was actuating the out-board brake carriers. As per Aircraft Maintenance Manual (AMM), this was an incorrect configuration.

After research it was noted that the hydraulic lines at the swivel fittings were reversed and were not properly installed on both main landing gears.

The aircraft arrived at the maintenance facility with no abnormalities noticed by the flight crew, however with these hydraulic lines reversed, the aircraft's anti-skid system would have worked opposite to the anti wheel-skid requirements and could have severely affected the controllability of the aircraft while landing in wet or bad weather conditions, including the possibility of tire failure.

The incorrect hyd. line installation configuration by maintenance.

All hydraulic lines were re-oriented correctly and the brake system was found serviceable.

Always ensure to follow all AMM task procedures. 🛠

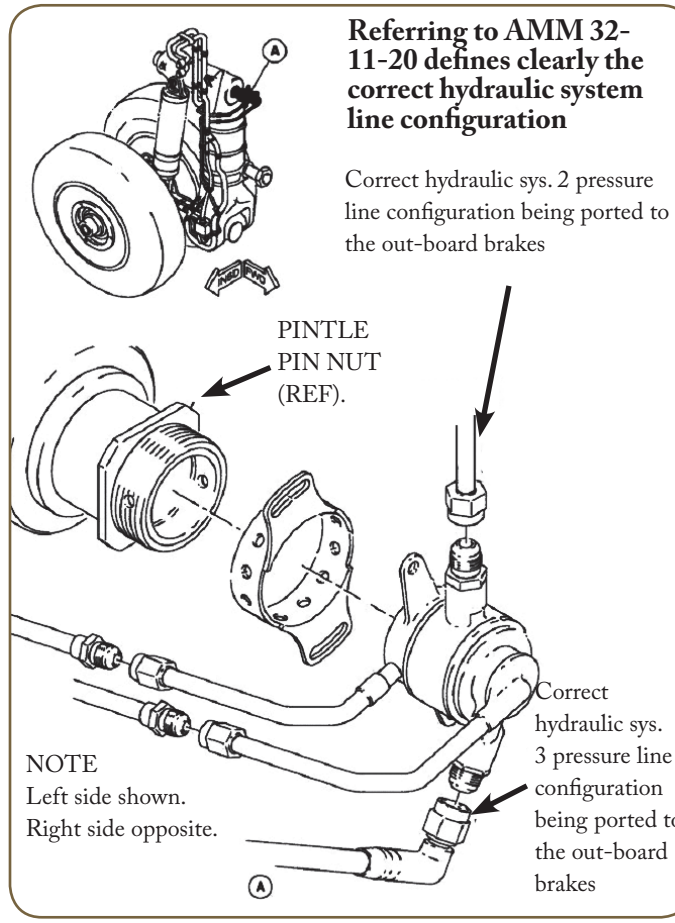
Referring to AMM 32-11-20 defines clearly the correct hydraulic system line configuration

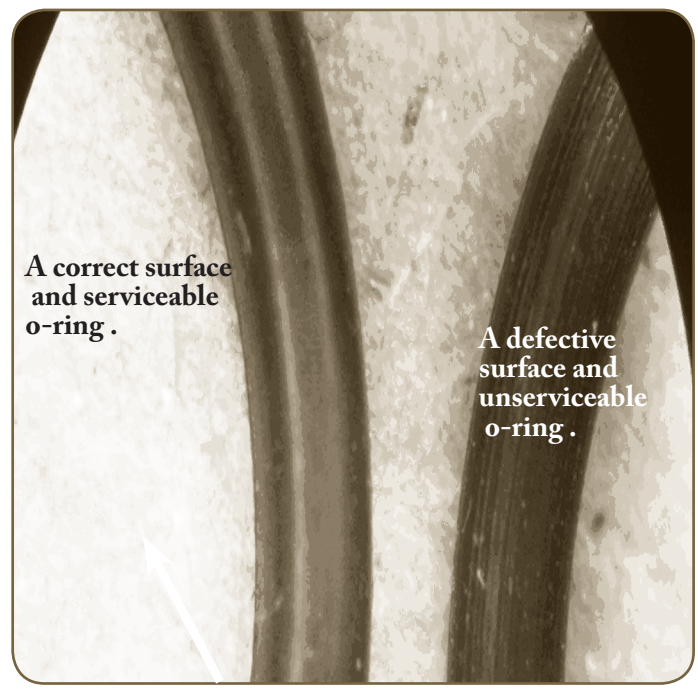
BOMBARDIER CRJ 100 SDR # 20100330001

During a heavy maintenance visit on a CRJ100 aircraft, multiple repeated snags for flat and deflated landing gear were raised. While replacing the nitrogen servicing schrader valve o-ring on the gear strut, it was noted by maintenance crew, that the new and old o-ring packings were found with a surface finish defect, causing the MLG gears to loose its gas charge.

A magnified visual inspection of the o-ring surface finish, as seen in the attached figure, confirmed this manufacturer's defect, in comparison to a correctly manufacturer o-ring.

Despite mandated quality assurance programs that exist throughout the industry, quality escapes still occur. Therefore it is essential that attention be given to the condition of serviceable parts being installed on aircraft.

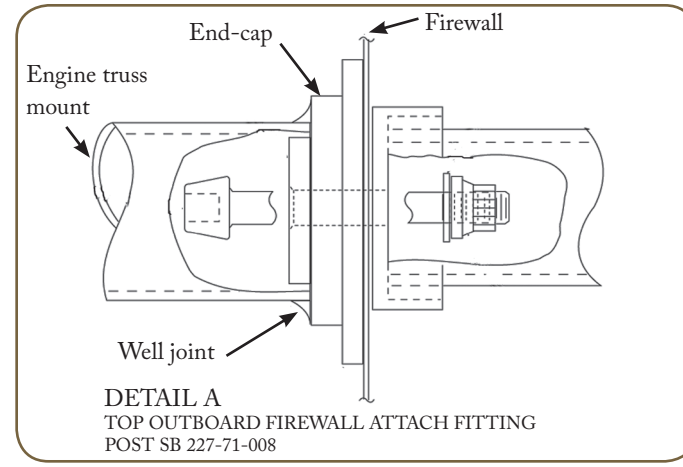
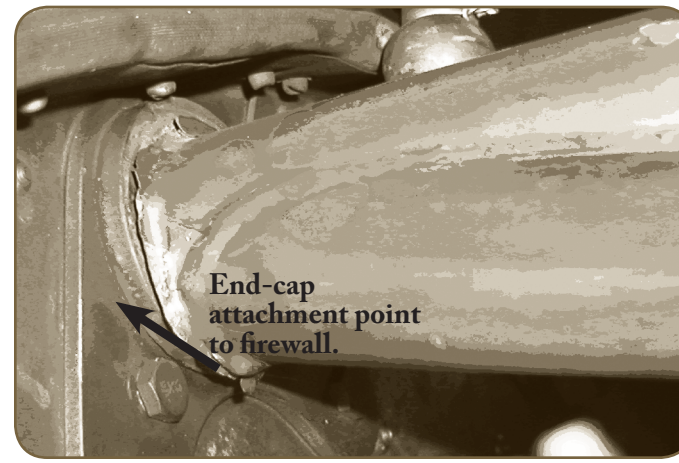
DETAIL A
TOP OUTBOARD FIREWALL ATTACH FITTING
POST SB 227-71-008

During a letter check inspection, maintenance found on the R/H engine, the upper outboard engine mount sheared off at the firewall attachment point.

The inner attachment bolt was still in place, however the engine support truss tube had separated from the flange or end-cap by a crack of the weld.

Failure of this weld could amount to a catastrophic failure of the aircraft.

The complete engine truss assembly was replaced with a serviceable unit.

TCCA would like to bring to the attention of all owners and operators, the importance of a detailed inspection of all engine mounts, especially following a turbulent flight, propeller strike or a hard landing. The Fairchild Service Bulletin 227-71-008 has been raised to address this end-cap fault.

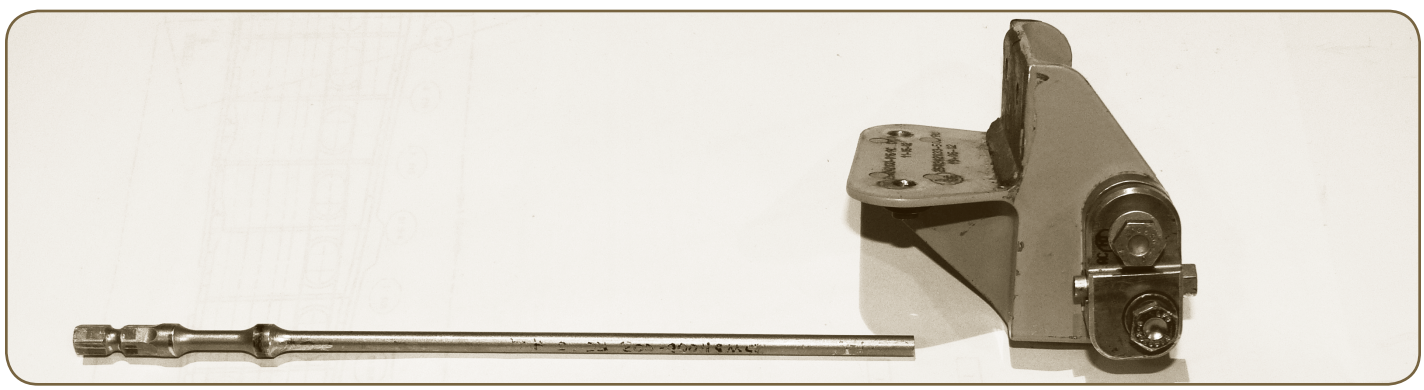
During a scheduled "B"- check maintenance visit, the R/H Aileron PCU External Centering Spring Rod was found broken.

TCCA is advising all operators and owners to inspect the condition of both the aileron PCU and the external centering spring rods.

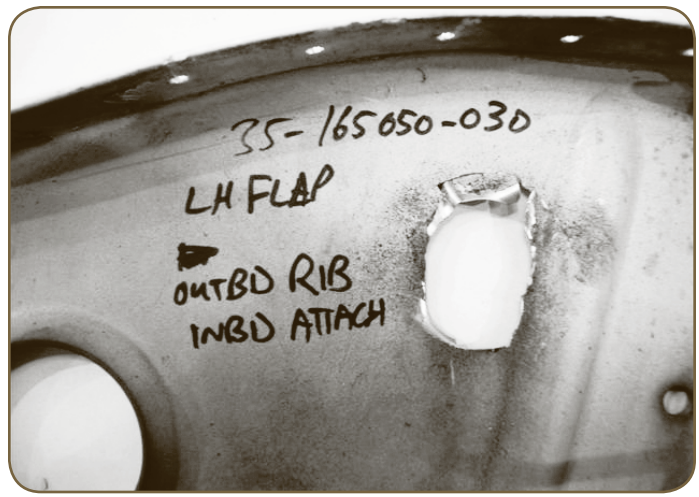
During descent to the airport, the appropriate flap selection was made when suddenly the flaps stopped and the ailerons became difficult to move. The crew then selected flaps up but no movement occurred. The crew declared an emergency and carried out an uneventful landing at a nearby airfield. It was later found that the aft attachment point on the L/H outboard flap, had failed inside the flap.

The flap is attached through two ribs on either side of the flap track. The flap roller assembly consists of a roller bearing, a large "hat" section and a Teflon washer. All these parts were found to be jammed into the flap track. It became apparent that the "hat" section bushing had been spinning and wearing into the outboard rib until the

material, 1.27 cm (0.50 inches) thick, eventually failed resulting in a jammed flap.

Further inspection revealed that the problem appears to originate with the roller bearings. The BC-56985 bearings are inside the large bushing and premature wear causes the bearing to move inside the bushing. The operator has modified their B300 inspection program to include a specific requirement to inspect this area both on the detailed 800 hour interval and the routine 200 hour interval inspection. A precautionary inspection on their other B300 aircraft revealed similar premature wear.

TCCA raised this issue with the FAA and Hawker Beechcraft (HBC) who stated that they have not had previous reports of this nature, however premature roller wear appears to be the root cause of this event. There is a previous service bulletin to replace the flap rib next to the actuator (not the rib next to the flap track). HBC have stated that the current maintenance instructions are specific on the inspection of this area.

It is important to note that flaps are at times subjected to significant aerodynamic loading (buffeting) during take off, approach and landing; thus it is important to carefully inspect these areas for premature wear and/or damage. It is also essential that flaps and all flight controls be precisely rigged in accordance with manufacturers instructions. 🛠

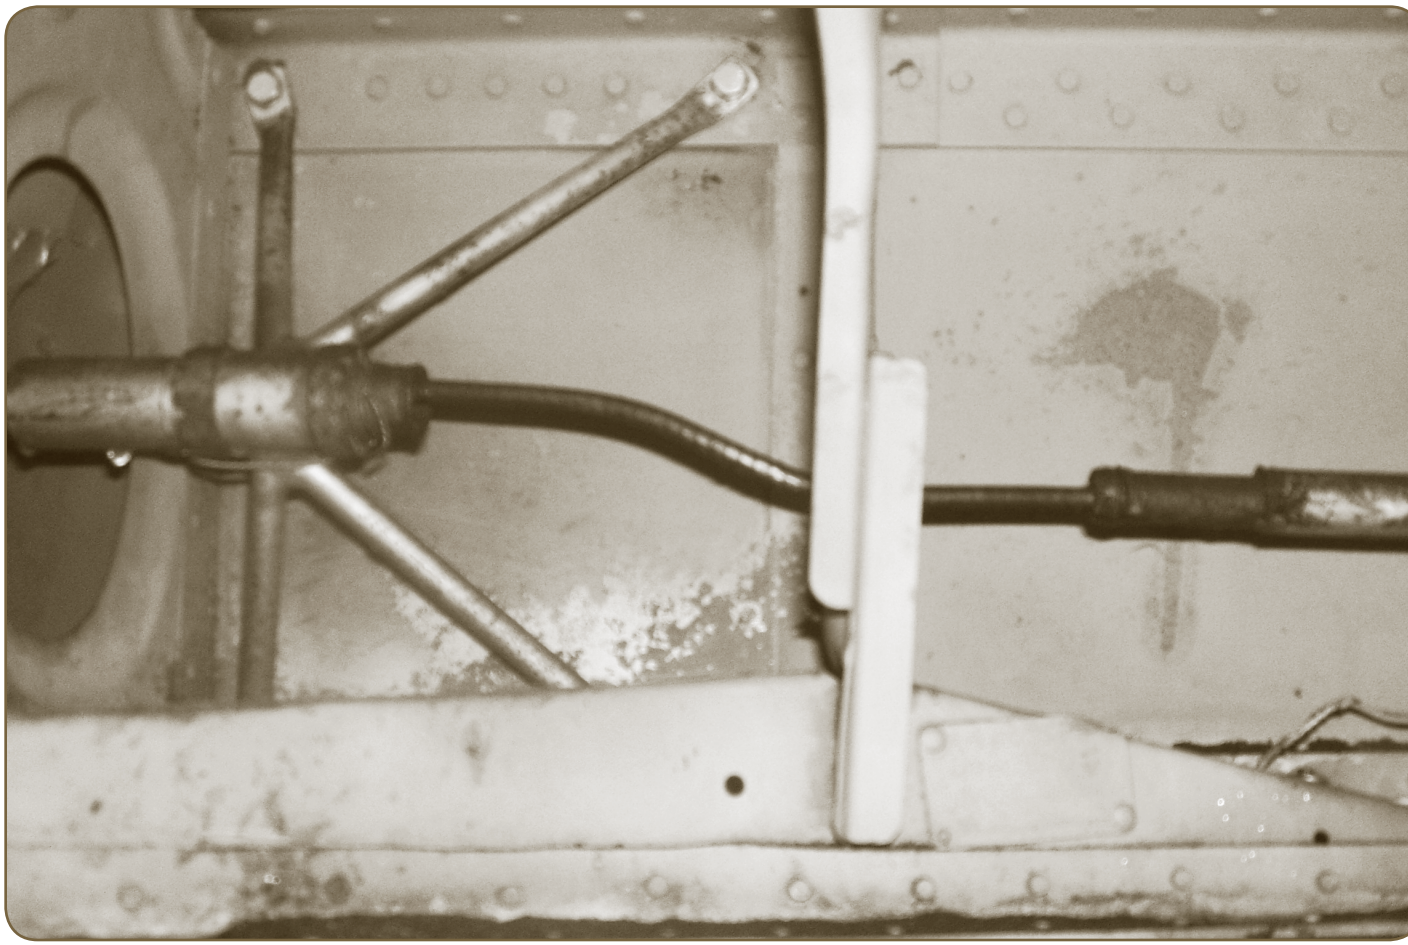
PIPER PA31 350 SDR # 20090616005

A domestic operator reported that the R/H landing gear collapsed during landing and caused the aircraft to veer off the runway. Subsequent investigation revealed that R/H retraction push-pull conduit was worn between the inner and outer sleeves. Separation of the sleeves did not allow the gear to extend to the full down and locked position. Significant corrosion was also found on the sleeve assembly.

A service history review has revealed numerous problems with the cable conduit assembly resulting in failure of the landing gear to extend fully or retract. Additionally, the retraction motor circuit breaker has popped on numerous occasions, which was directly linked to lack of lubrication of pertinent parts. Other defects such as binding or worn cables have also caused landing gear malfunctions.

The electrically powered landing gear is subject to environmental contaminants that promote corrosion, thus it is essential that adequate lubrication and inspections be carried out. Inspect push-pull cables for signs of excess wear, corrosion, freedom of movement and bends and cracks of the threaded ends.

Please also refer to FAA Special Airworthiness Information Bulletin (SAIB) CE-08-50 titled "Landing Gear Manual Extension System Inspection" and Piper Service Letter 782B. These documents emphasize the importance of regular/preventive maintenance. 🛠

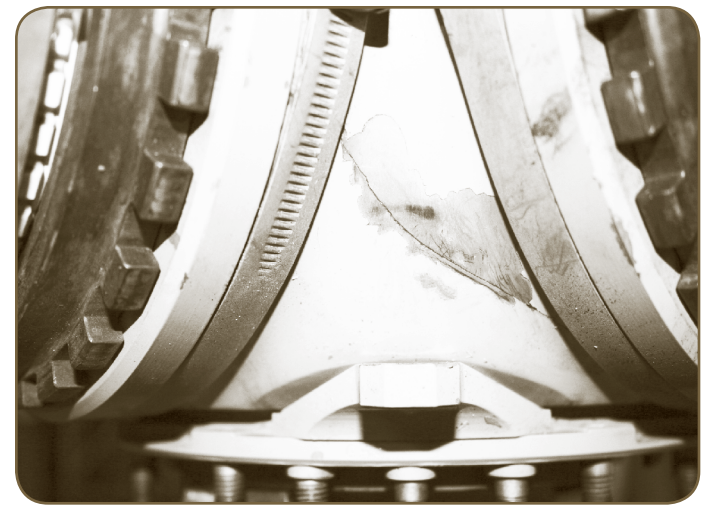
After a flight the crew raised a snag for excessive L/H propeller vibration. Maintenance performed an inspection and found the propeller with a significant crack.

The propeller hub assembly was removed and replaced prior to its next flight.

TCCA would like to advise all operators and owners that for any form of vibration, it is essential that the source is found and rectified prior to the next flight.
