Learn from the mistakes of others; you'll not live long enough to make them all yourself . . . **Issue 1/2004**

Sometimes You Do, Sometimes You Don't...

On June 11, 2002, a Piper PA-31-350 Chieftain was on an instrument flight rules (IFR) flight from Gunisao Lake, Man., to Winnipeg. One pilot and six passengers were on board. At 09:13 central daylight time (CDT), the aircraft began an instrument landing system (ILS) approach to Runway 13 at Winnipeg International Airport. The captain flew the approach at a higher-than-normal approach air-speed, well above the glide path. When the aircraft broke out of the cloud layer, it was not in position to land safely on the remaining runway. The captain executed a missed approach at 09:16, and shortly thereafter, at 09:18, the captain declared a 'Mayday' for an engine failure. Less than 20 seconds later the captain transmitted that the aircraft had experienced a double engine failure. The aircraft crashed at a major traffic intersection at 09:20, striking traffic signals and several vehicles. All seven of the aircraft passengers and several of the vehicle occupants were seriously injured; one passenger subsequently died of his injuries. The

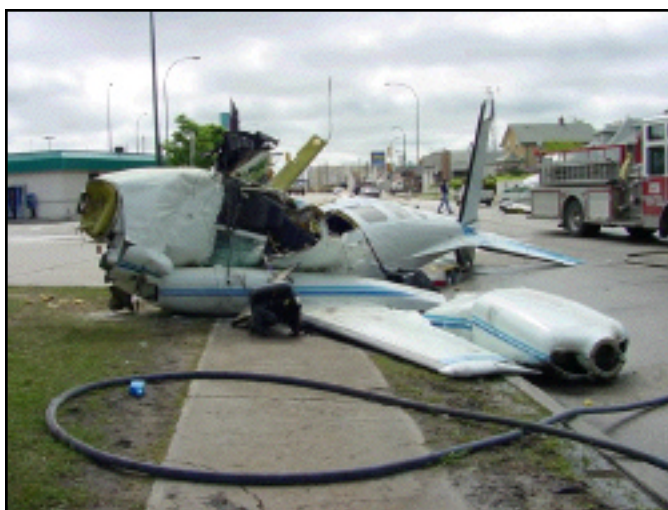
Before the aircraft was on approach into Winnipeg, the right engine low fuel pressure light illuminated and the right engine sputtered. Fuel cross feed was selected. The right low fuel pressure light then went out and the engine returned to normal operation. The pilot did not declare an emergency or ask for assistance during the return flight to Winnipeg before executing the missed approach. *(It is unfortunately common practice for some pilots to delay declaring a fuel emergency until it is too late; while it may save their lives, pilots would rather risk death than face self-exposure to reckless planning and all the paperwork associated with declaring an emergency...keep reading)*

The pilot flew the ILS Runway 13 at Winnipeg, recognizing that the fuel situation was critical and that engine power loss was imminent. He intentionally flew the aircraft well above the glide path for the ILS and at speeds significantly faster than normal, in order to have more time to respond to an engine power loss. The aircraft crossed the missed approach point well above the glide path. The pilot continued to descend past the missed approach point and was observed by tower controllers after breaking out of the cloud layer at about 200 ft AGL, with about 3 200 ft of runway remaining. *(The pilot knew he was in serious trouble at the missed approach point and that a successful missed approach was not in the cards; yet he did not declare an emergency because he still thought, at that*

There were no pre-existing mechanical problems with the aircraft, and no indication of fuel leaking or venting. The operator’s OM required that the pilot-in-command of a Navajo aircraft on an IFR flight ensure that there is sufficient fuel to fly to the destination, execute an approach and a missed approach, and then fly to the alternate aerodrome and land with a reserve of 45 min. It also stated that all flights must be authorized by the Operations Manager or Chief Pilot and that a flight release will not be given until the pilot-in-command has completed an operational flight plan. However, company supervisory personnel indicate that, in practice, a flight release is not required and that a pilot self-dispatch system is used. The OM also requires that a weight and balance form be completed for each flight and signed by the pilot-in-command.

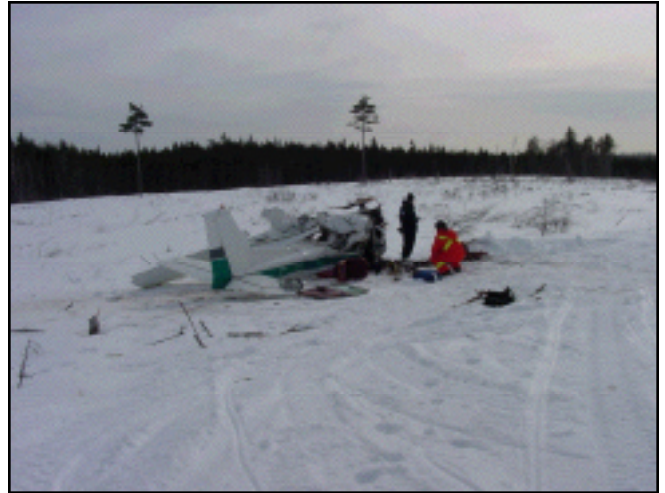
The accident site was in a snow-covered, clear-cut area on the east side of the pipeline, just beyond a small grove of trees. The clear-cut area extends approximately 1 mi. back along the flight path before reaching a large uncut area of trees. The terrain is gently up-sloping from the uncut area of trees to beyond the accident site. The right wing, right wing strut, and right main landing gear tire struck the top portion of a spruce tree that was sticking up above all other trees and broke it off at approximately 55 ft AGL; even with the tops of other trees. The impact with the tree caused the right wing to separate from the aircraft. The aircraft then rolled inverted and travelled 547 ft before striking the ground in an 80° nose-down, inverted attitude. After impact with the ground, the aircraft flipped over and came to rest in an upright attitude, facing the opposite direction of flight. The tree impact damage on the right wing, right wing strut, and right main landing gear corresponds to a wings-level attitude at initial impact.

Analysis—The aircraft was operating normally prior to impact and is not considered to be a factor in the accident. Also, there was no pre-existing physiological condition found that might have impaired the pilot's performance. Radar data showed that the aircraft was flown along terrain contours at altitudes well below those required for effective observation. The aircraft was flown consistently below 500 ft AGL, and recorded on radar as low as 150 to 250 ft AGL. When the aircraft struck the tree, it would have been only 55 to 60 ft above the ground.
