TP 185E
Issue 1/2013

AVIATION SAFETY LETTER

In this issue...

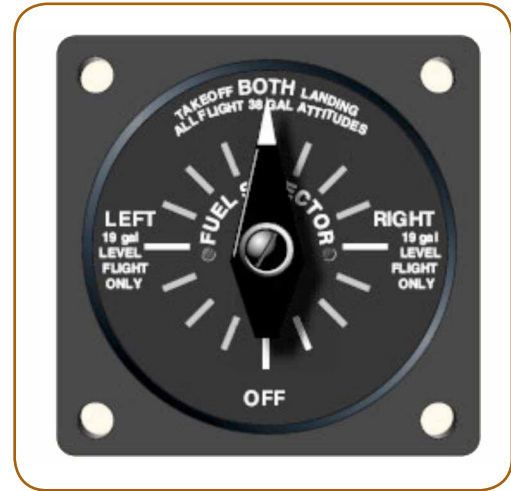
There is no ON position on this valve; only BOTH, RIGHT, OFF, and LEFT.

The fuel valve on that C172 was different than the fuel valve I was used to in the C152. The rotary type of valve on the C172 could be selected to left tank only, right tank only, both tanks, or off. The C152 fuel valve I was accustomed to had only two options: on or off.

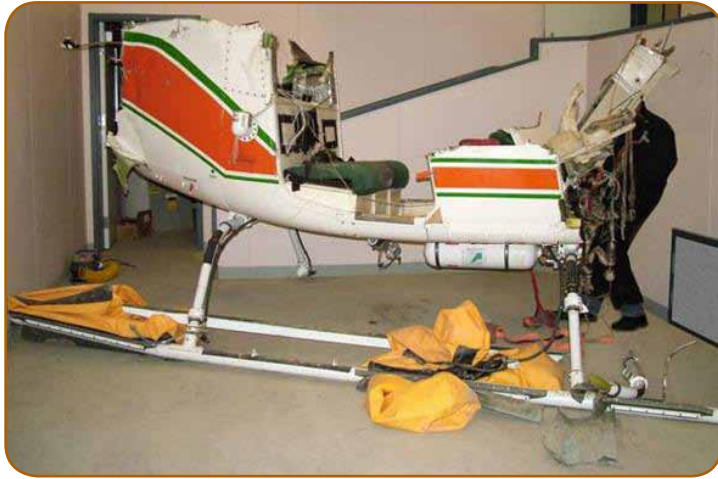
Recovered fuselage

The engine, most of the cockpit, and most of the tail section were not recovered. The fracture surfaces observed on the recovered sections were attributed to overstress as a result of water impact. The degree of helicopter break-up and damage to the recovered sections indicate an impact at a speed in excess of that associated with an emergency landing. The fracture surfaces exhibited characteristics that indicate the helicopter hit the water in forward flight with a left bank. The degree of bank could not be determined. No indications of pre-existing fractures were observed on the recovered wreckage.

The left landing gear had separated along with its pop-out floats. The pop-out floats on the right skid were found deployed when the wreckage was recovered, and were keeping the wreckage afloat. There was insufficient wreckage recovered to rule out the possibility of a mechanical anomaly which could have triggered a caution light and an emergency landing. The fuel tank was recovered intact and was partially full. A fuel sample was sent for laboratory analysis and no anomalies were detected.

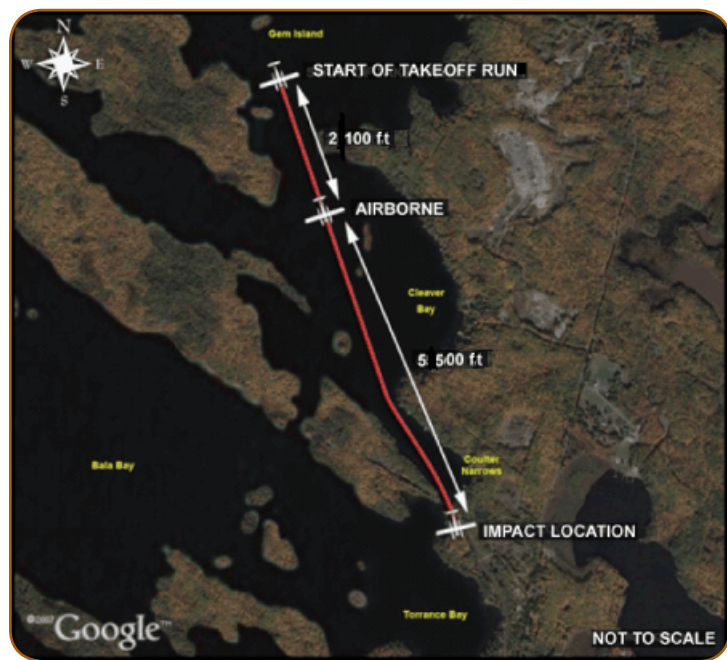
Estimated flight path

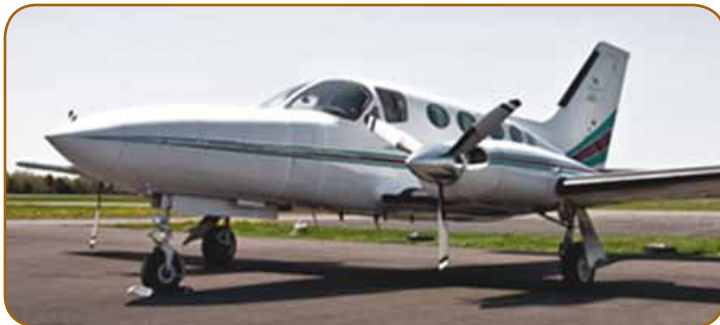
Occurrence aircraft

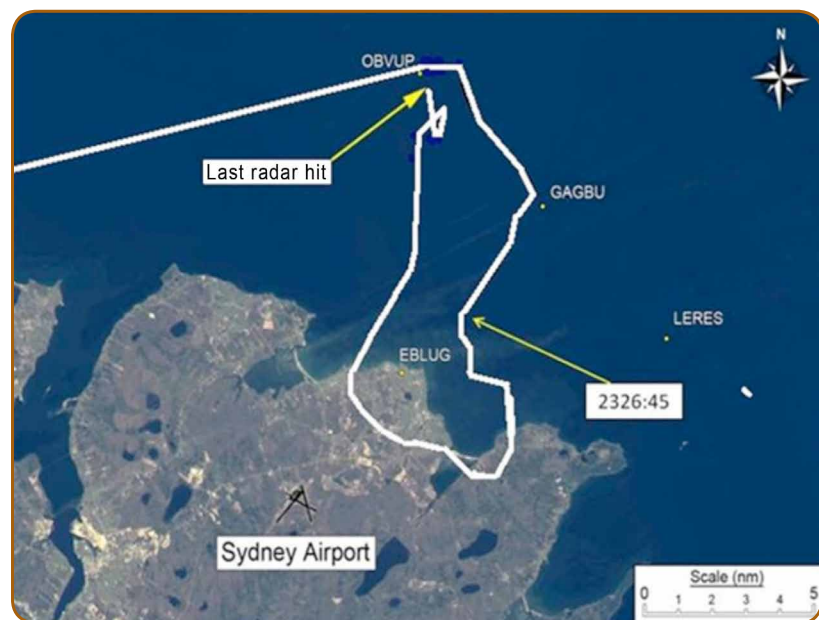
Aircraft flight path

The aircraft track nearing OBVUP created a sharp closing angle on the OBVUP-GAGBU track. As the aircraft neared the OBVUP waypoint, the course track bar on the GPS would have moved very quickly toward the GAGBU waypoint. Due to the maximum rate of turn that an autopilot system allows, the aircraft would have flown through the OBVUP-GAGBU track before regaining course. To prevent

this, a pilot would have to manually take control and initiate a steep turn. In an attempt to intercept the OBVUP-GAGBU course, an inexperienced pilot may try to follow the track bar using an increasingly steep bank angle. If this steep bank angle is left uncorrected, a spiral dive will result.

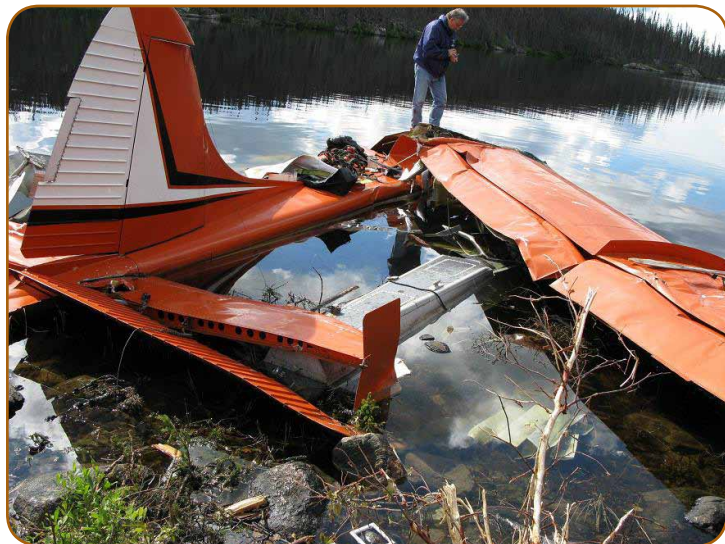
On June 30, 2011, a float-equipped de Havilland DHC-2 departed from a lake adjacent to a remote fishing cabin near Buss Lakes, Sask., for a day VFR flight to Southend, Sask., about 37 NM southeast. There were four passengers and one pilot on board. The aircraft crashed along the shoreline of another lake located about 2 NM southeast of its point of departure. The impact was severe and the five occupants were killed on impact. The emergency locator transmitter (ELT) activated, and the aircraft was found partially submerged in shallow water with the right wing tip resting on the shore. There was no post-crash fire. The accident occurred during daylight hours at about 1111 Central Standard Time (CST).
