Transport
Canada

TP 185E
Issue 3/2007

AVIATION SAFETY LETTER

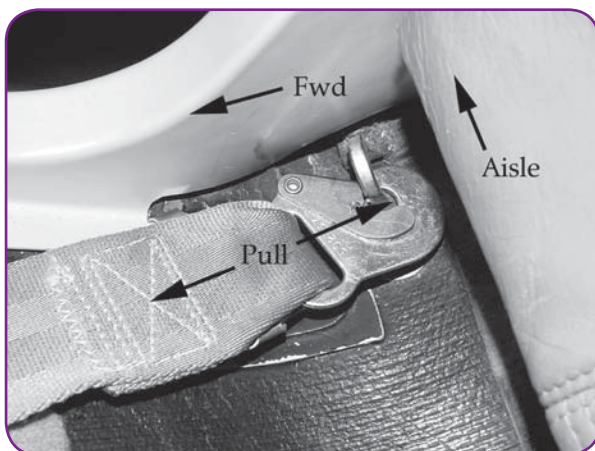
Figure 1: Seat belt hook snapped onto U-shaped fitting—pull is on hook

The two seats belts that failed were from the aisle seat locations. The seat belts, part number 502745-E-2847, model number 502751, are manufactured by AmSafe Inc. of Phoenix, Ariz. The seat belts are snapped onto the seat attachment point with a hook, which incorporates a spring keeper for quick installation and removal. The seat, ID number 8S0151-1/-2, is manufactured by PTC Aerospace (now owned by B/E Aerospace). The seat incorporates a U-shaped attachment fitting bolted to the seat structure to accommodate the seat belt.

The two seat belts that failed had flipped around the U-shaped attachment fitting, and became lodged under a plastic trim molding on the side of the seat, adjacent to the aisle. A direct pull on the belt bent the spring keeper to the side, allowing the belts to become detached, even though the hook remained undamaged.

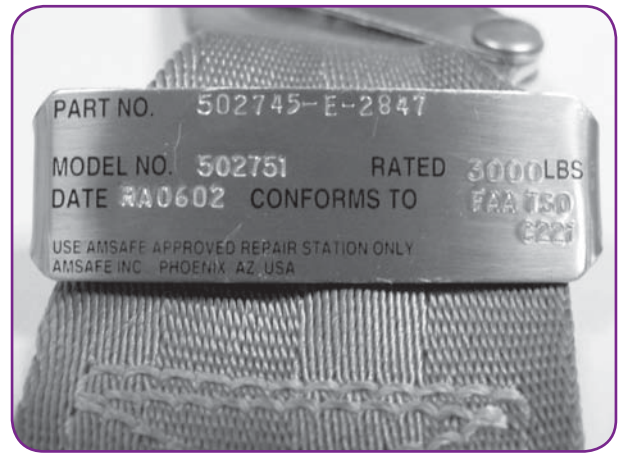
Figure 4: Seat belt identification

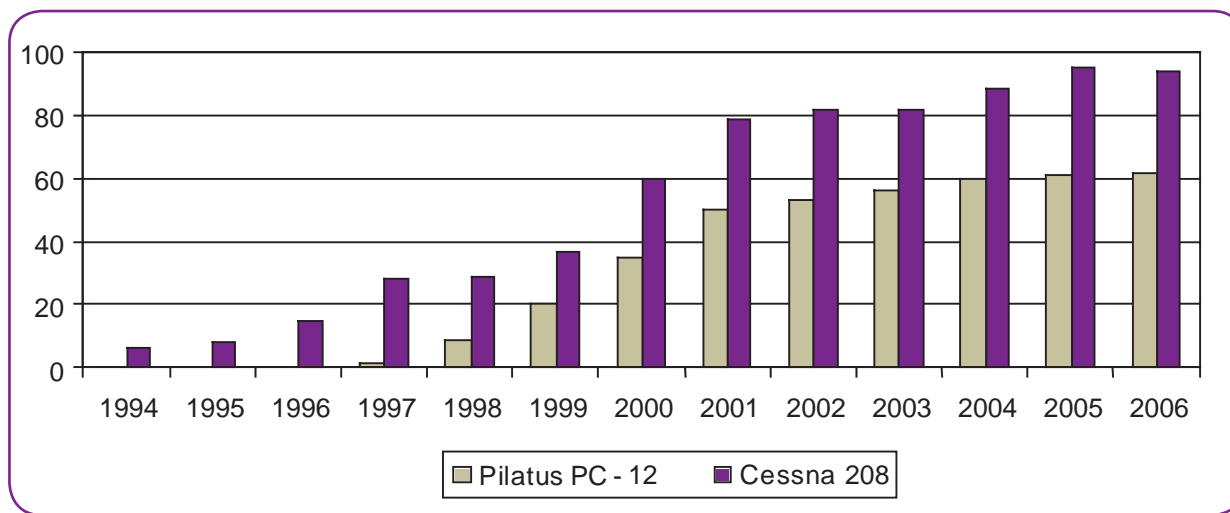
Figure 1: SEIFR Aircraft Registered 1994–2006

Since 1995, Canadian operators have steadily purchased more SEIFR aircraft. Currently there are ninety-six C208 and sixty-four PC-12 aircraft registered. Figure 1 displays the change year-over-year in PC-12 and C208 registration. A third type, the Socata TBM 700 is operated in Canada in much smaller numbers than the C208 and PC-12, as evidenced in Table 3.

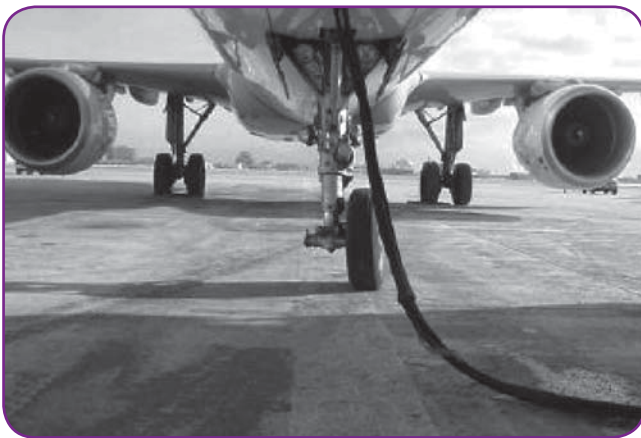
Aircraft at the gate, shortly after arrival

On January 19, 2004, at approximately 14:10 Eastern Standard Time (EST), an Airbus A321-214 landed on Runway 06L at Lester B. Pearson International Airport, Toronto, Ont., after a flight from Montréal, Que. While taxiing to the terminal, the flight crew heard a noise from the nose landing gear area. As the aircraft turned onto the lead-in line at the gate, the ground marshallers observed that the right-hand nose wheel was missing, and immediately had the aircraft stopped. Maintenance personnel inspected the nose landing gear and determined that it was safe for the aircraft to proceed to the gate. Airport authorities closed Runway 06L to inspect for aircraft components and landing surface damage. The nose wheel was subsequently located on the ramp. There were no injuries and damage to the aircraft was limited to the nose landing gear assembly. The damaged components were removed from the aircraft and shipped to the TSB Engineering Branch for examination.

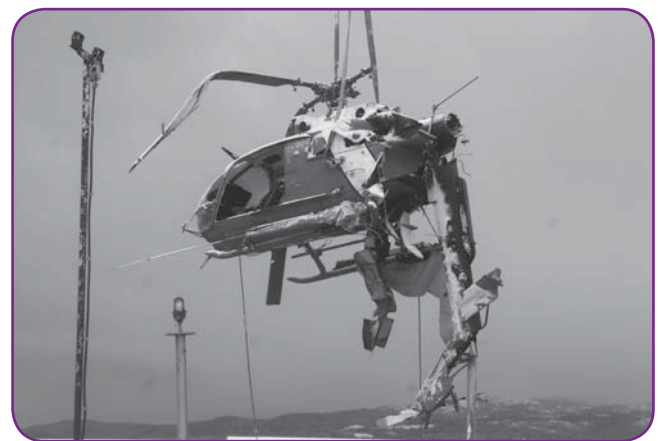
Aircraft during recovery, with cabin largely intact

On December 7, 2005, a Messerschmitt-Boelkow-Blohm (MBB) BO-105 helicopter was being used for various tasks associated with the upkeep and operation of lighthouse and coastal navigation facilities in the Burin Peninsula area of Newfoundland and Labrador. While returning to Marystown, N.L., in the late afternoon of December 7, 2005, with one pilot and one passenger on board, the helicopter encountered heavy snow showers, and at about 16:28 Newfoundland Standard Time (NST), the helicopter crashed into the water of Mortier Bay, east of Marystown. Both the pilot and the passenger survived the water impact and escaped from the helicopter. However, the pilot perished from hypothermia, and the passenger drowned.

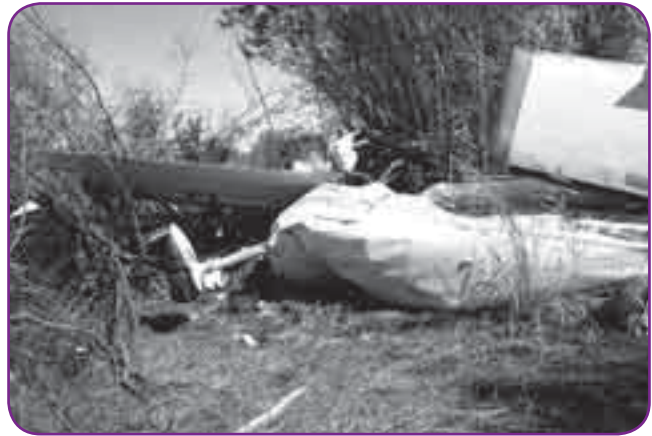
On August 19, 2006, a Cessna 177B Cardinal departed the pilot’s farm airstrip, 5 NM east of Manning, Alta., at about 21:25 Mountain Daylight Time (MDT). The flight was a local sightseeing trip with three passengers. At 21:35, the aircraft was observed approaching a community centre 5 NM south of the take-off point, where a sporting event was underway. The aircraft approached from the northeast and made a slow-speed pass at a height estimated at between 150 and 500 ft above ground level (AGL). It then made a steep turn to the left, followed by a steep climbing right turn. The nose then dropped sharply and the aircraft entered a spin of two turns. The rate of spin slowed before the aircraft impacted the ground in a near-vertical, nose-down attitude in light brush. There was no post-impact fire, and all four occupants sustained fatal injuries. The nature of the damage and ground scars indicated a very rapid deceleration and high-impact forces.

On-site inspection of the wreckage by investigators from the Transportation Safety Board of Canada (TSB) revealed no pre-impact malfunction that would have contributed to the accident. The engine was heard to operate all the way to the ground, and examination of the wreckage confirmed that the engine was likely developing power on impact. All flight controls were continuous, and the flaps were in the retracted position. The left-wing tank contained fuel, and the right-wing tank, which was heavily damaged, held no fuel. Fuel was observed leaking from the wreckage shortly after the accident. The aircraft weight and centre of gravity were estimated to be within certified limits.
