Issue 4/2002

Flight 2005—We've Now Reached Our Cruising Altitude

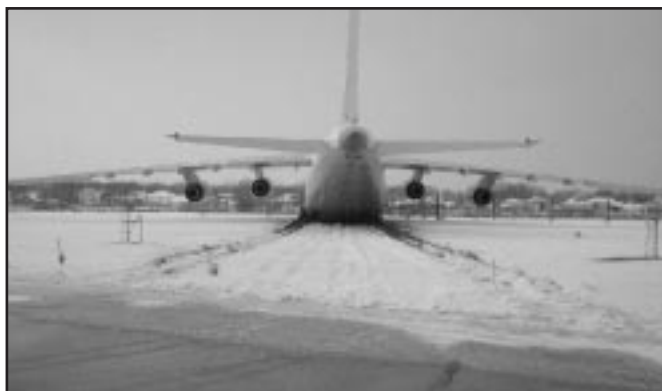
TSB Final Report A0000279—Runway Overrun

On December 18, 2000, an Antonov 124-100, was chartered to pick up 40 t of auto parts from Windsor, Ontario, for delivery to Oostende, Belgium. The crew conducted an instrument landing system approach to Runway 25 at Windsor Airport, and the aircraft touched down an estimated 3400 ft past the runway threshold, at about 23:33 EST (eastern standard time). During the landing roll, the aircraft overran the runway and stopped approximately 340 ft past the end of the runway, 20 ft from the airport boundary fence. There were no injuries, and the aircraft sustained minor damage. Emergency response services responded approximately 40 s after the aircraft stopped.

1. The aircraft touched down 3400 ft past the threshold of Runway 25 and could not be stopped in the remaining 4450 ft.
2. Because of the weather minima on Runway 07, the aircraft was landed with a 4-kt tailwind component on Runway 25. The aircraft was about 20 ft higher and about 6 kt faster than recommended when it crossed the threshold of Runway 25. Consequently, the aircraft touched down well beyond the normal touchdown point.
3. The runway was covered with a trace of loose snow, which reduced braking friction and lengthened the landing roll.
4. The Canadian runway friction index (CRFI) report of 0.30, issued to air traffic control by the airport maintenance specialist, was not passed to the AN124 flight crew. This resulted in the flight

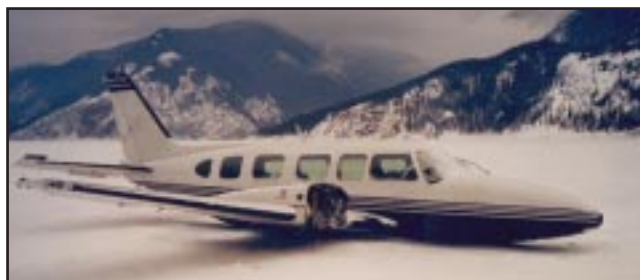
TSB Final Report A00P0019—Controlled Flight onto Ice

On February 7, 2000, the pilot of a Piper PA-31-350 Navajo Chieftain encountered an area of heavy snow and reduced visibility while on a visual flight rules (VFR) flight from Bear Valley, British Columbia, logging camp to Tsay Keh. The pilot was unable to maintain visual references and executed a

180° turn in an attempt to regain visual flight. Shortly after completing the turn, at about 10:55 PST (pacific standard time), the aircraft collided with the ice on the Peace Reach Arm of Williston Lake, British Columbia. The pilot was the sole occupant of the aircraft and received serious injuries. There was no fire. The aircraft was destroyed during the collision.

1. Weather conditions at the time and location of the occurrence were not suitable for visual flight.

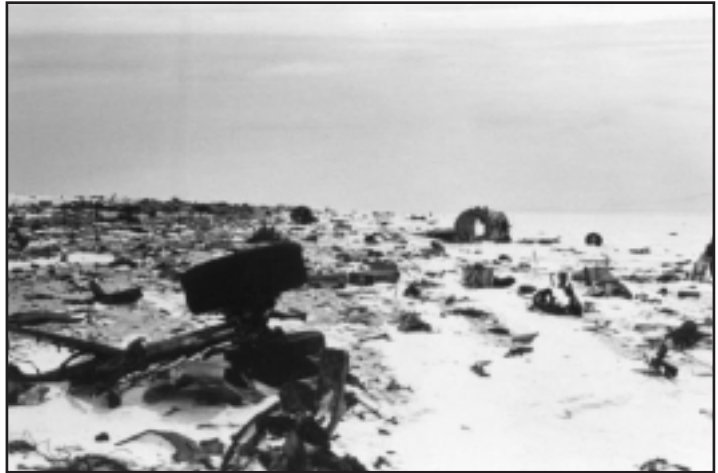
Photo: New Zealand Transport Accident Investigation Commission
Wreckage trail looking North.
